Gabriel Weiss
Stonemason
CCB#161243
4115 SE 30th Ave
Portland, Oregon
97202

10/4/15

Assessment of Masonry in the Peninsula Park Rose Garden

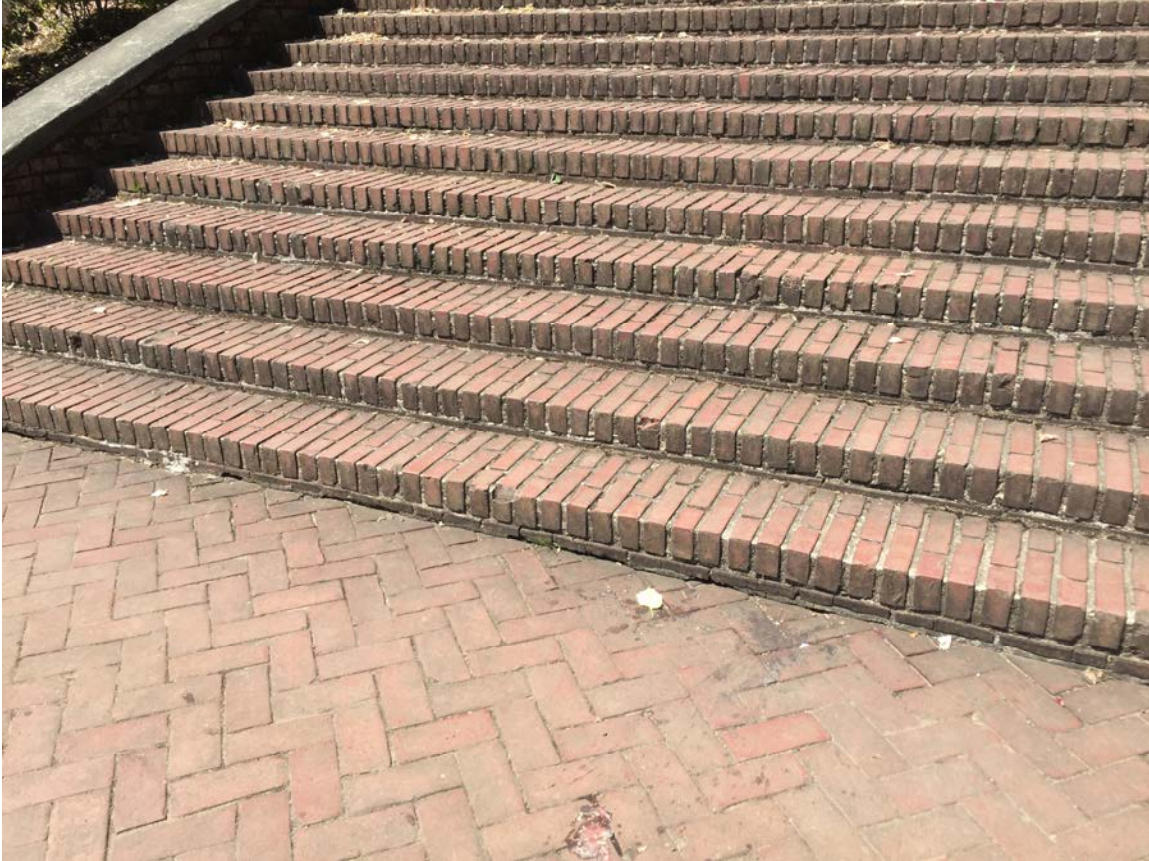
Steps in the PPRG in need of repointing

Mortar used between bricks, whether walls or flatwork, has deteriorated. This is normal wear, brought on by the movement of water into and out of the mortar, the accumulation of organic matter such as moss in mortar voids, and the effect of freeze-thaw cycles on mortar. The result is a slow deterioration of mortar as the mineral matrix of the mortar breaks down.

a. **Repointing of vertical surfaces:** The brick walls of the Peninsula Park Rose Garden contain mortar that is softer and more plastic than that of the flatwork in the garden. These mortar joints should be cut back at least 5/8" and repointed with mortar of like lime/portland cement/sand ratio as the existing mortar.

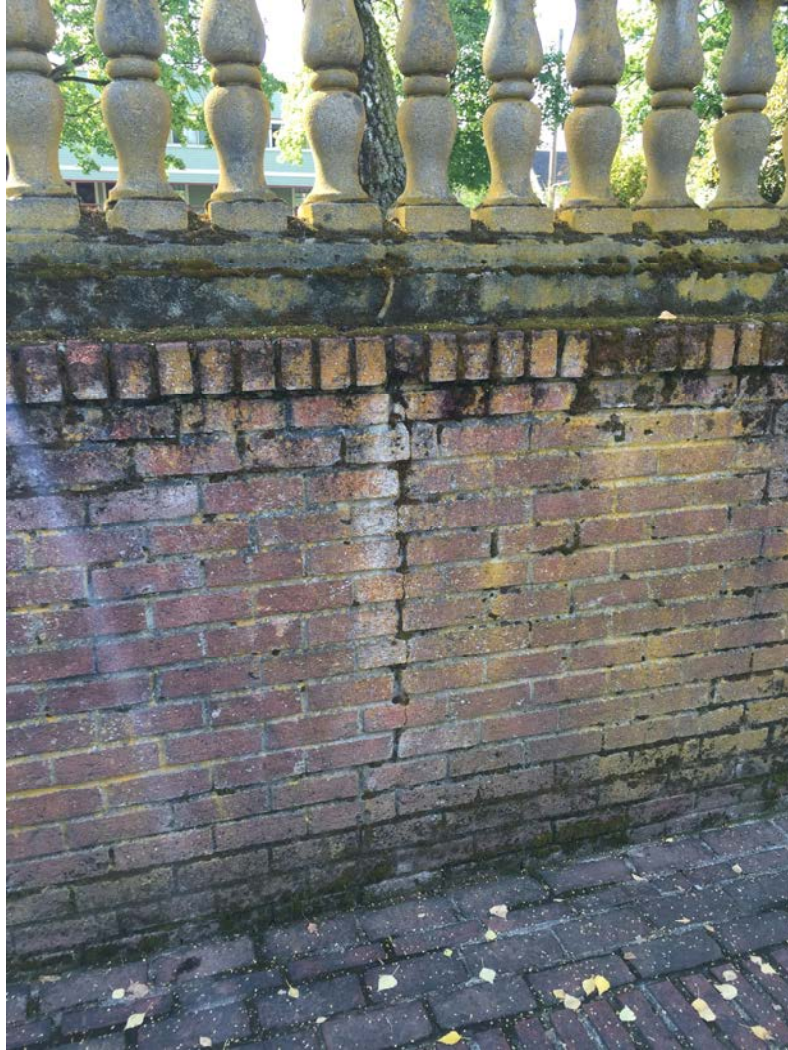
In some places, the vertical walls demonstrate fissures that run the full height of the wall, as below certain parts of the cast concrete bannister. These fissures should be prioritized as water and other elements entering through such fissures poses a threat to the longevity of the masonry.

Brick wall below cast concrete balustrade. Note long vertical crack infilling with moss and wider at the top than bottom. Crack extends to coping above.

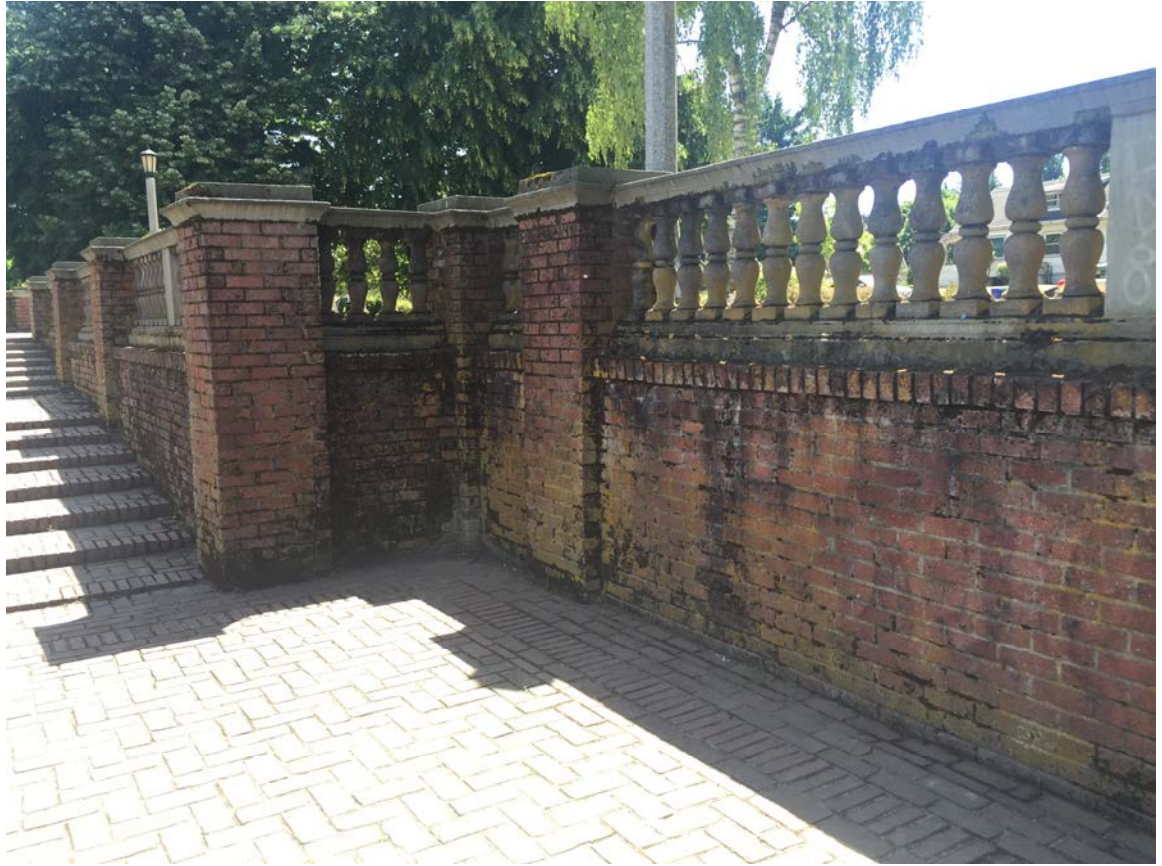
Wall and columns in need of repointing. Vertical joints in brick that overhangs face is in greatest need of repoint. For efficiency and uniformity of repair, sections of app. 200-350sf should be chosen for repoint at one time, beginning with areas in greatest disrepair.

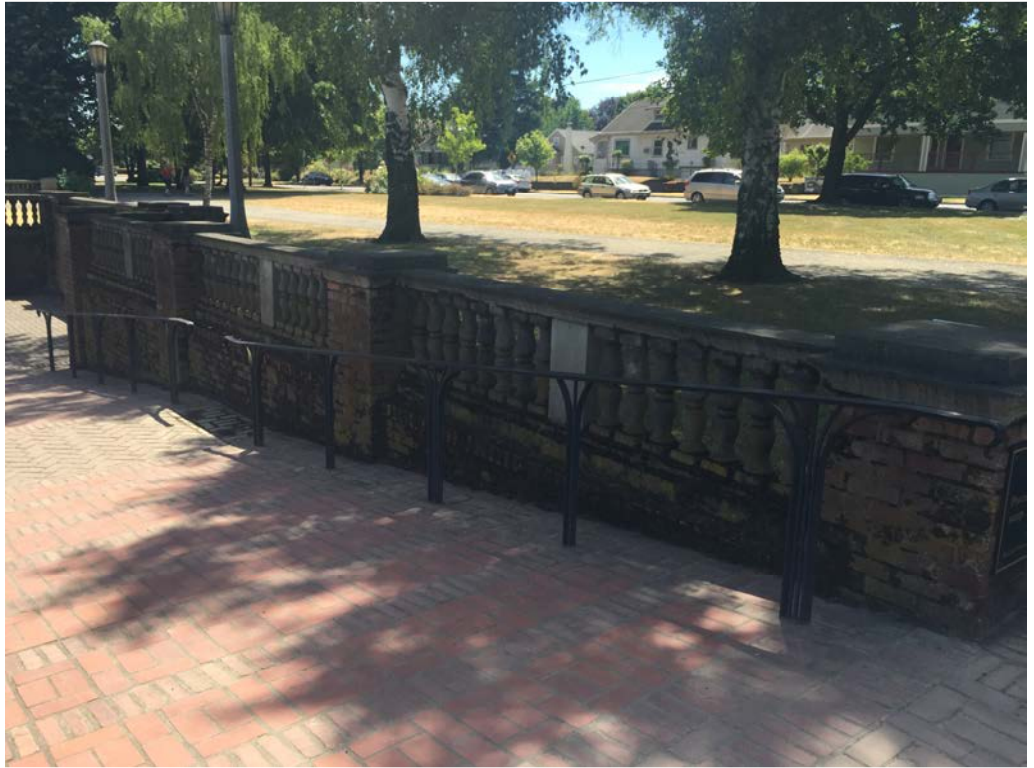
Heavy accumulation of moss on vertical wall below balustrade; moss must first be removed with a wire brush to prevent accelerated decay and to assess relative need for repoint.

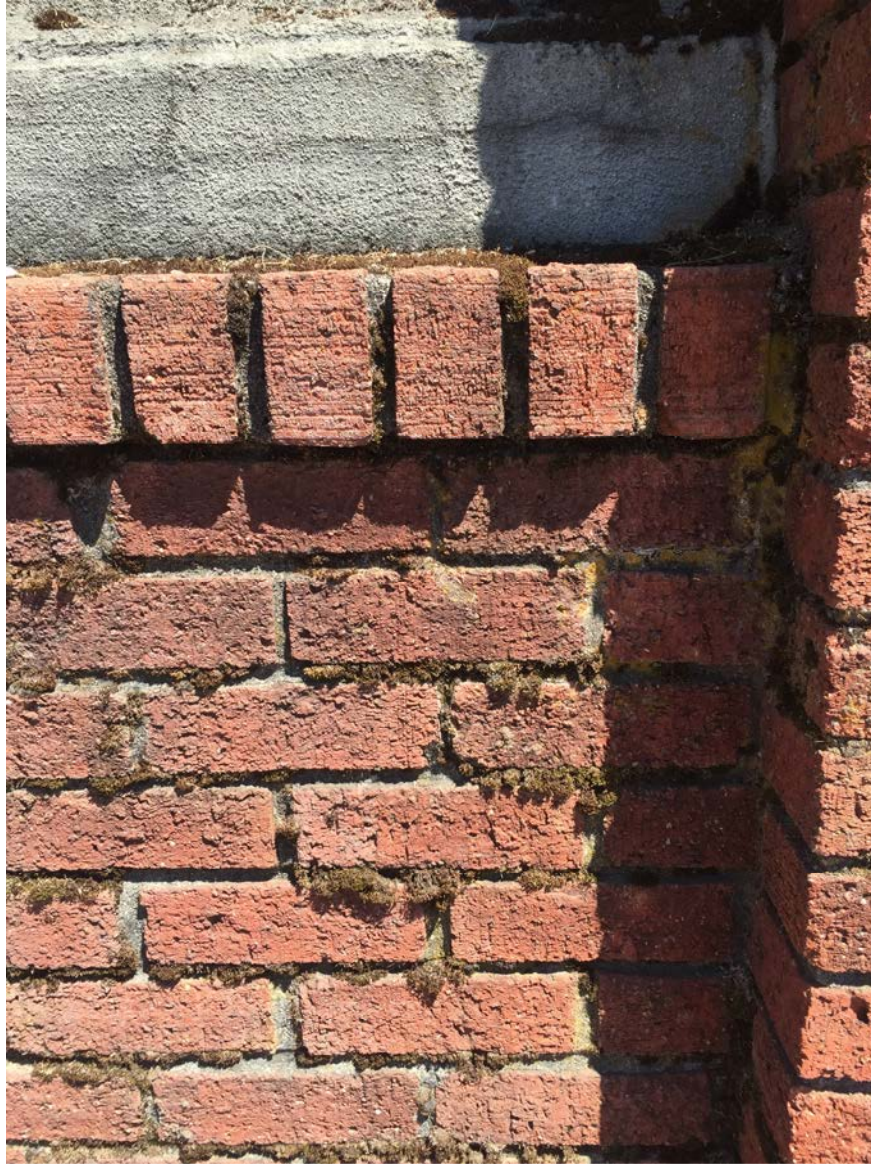
Detail of wall during summer, showing accumulation of moss in deteriorated mortar. Note that moss finds a toehold in deteriorated mortar joints while accelerating the growth of these defects.

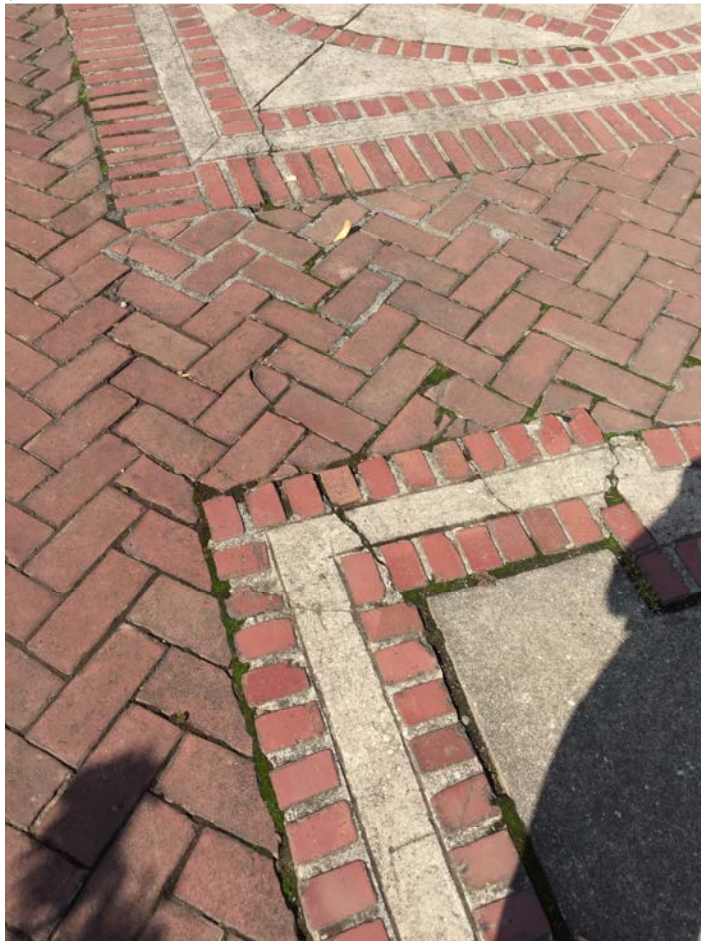
Flatwork exhibiting fissures between herringbone brick and concrete border

This work will be similar to that performed in 2014 by our company. A topping mix (or sand mix – consisting of sand and portland cement only) should be used in these areas. Mortar should *not* be used, as it will not match the appearance of the surrounding work over time, nor will it withstand the wear and tear of use or effects of precipitation.

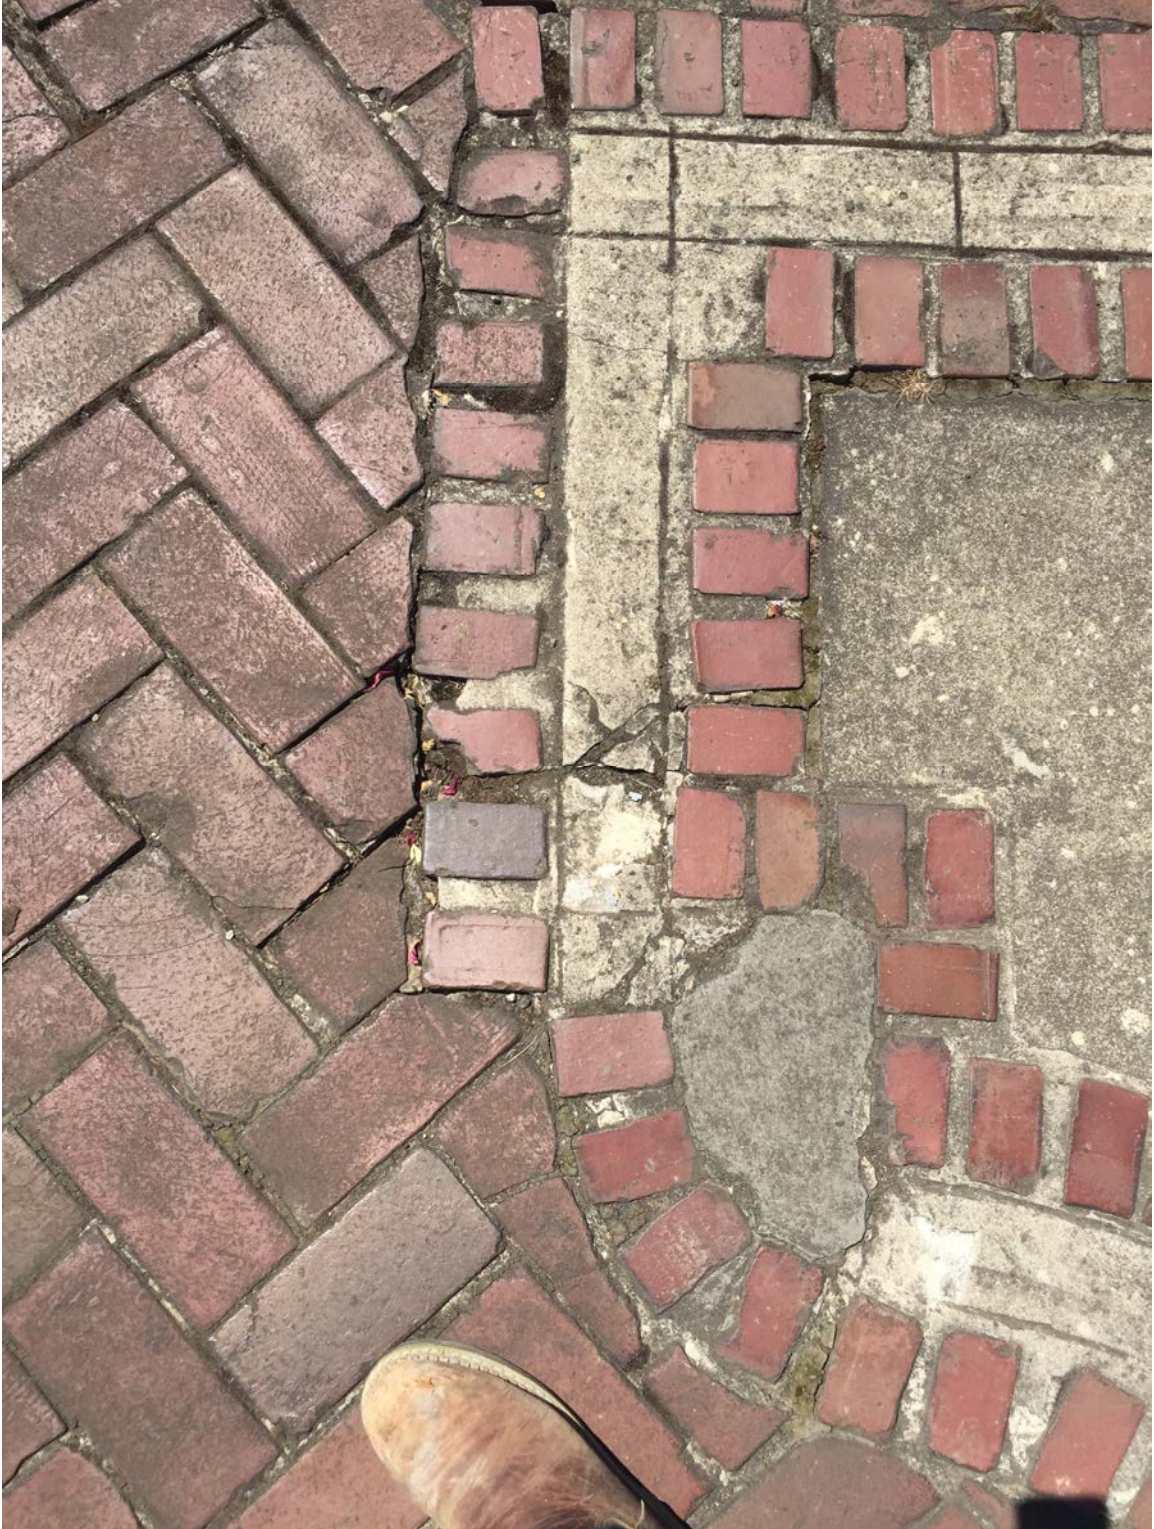
Area of Flatwork requiring a variety of techniques to resurface: Herringbone brick requires repointing with sandmix and may need to be reseated; brick-end border requires repoint and sandmix top surface requires attention.

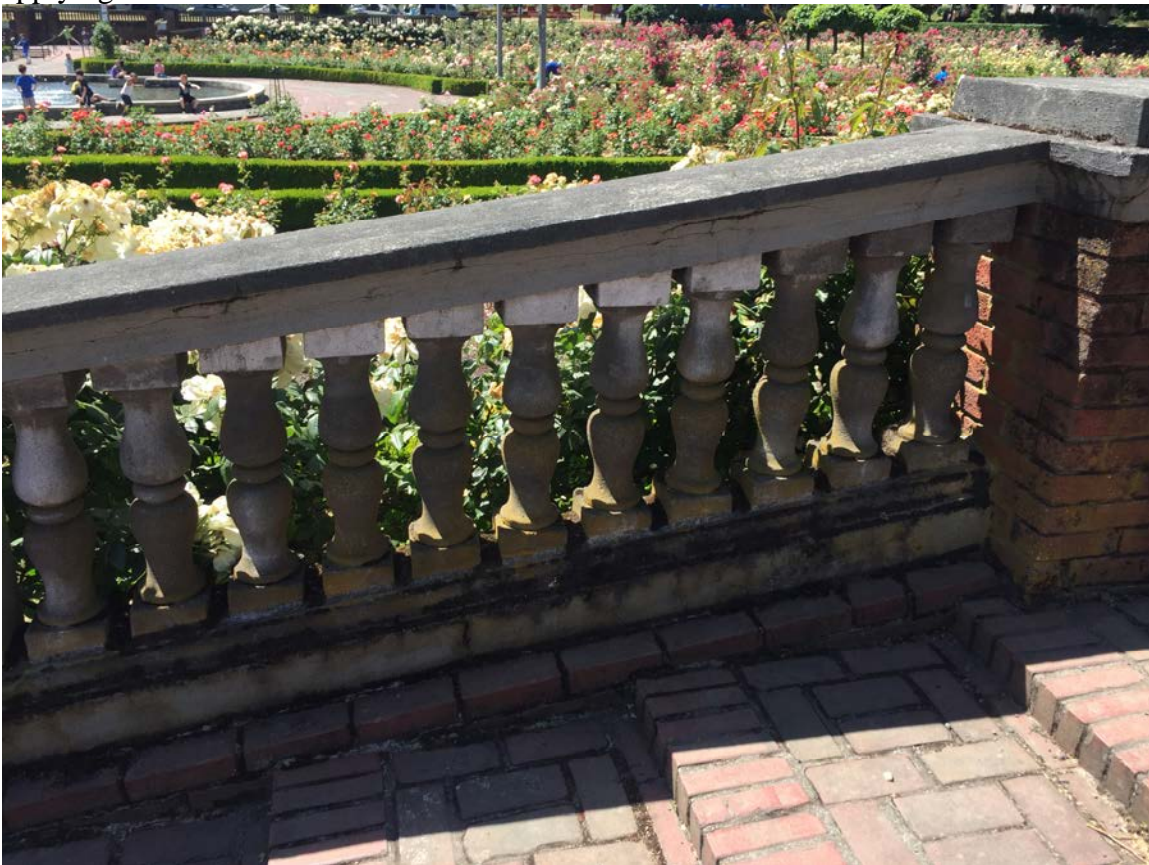
The balustrades and pier caps in the garden are suffering differing degrees of deterioration. Pier caps, copings, and balusters in the garden consist of metal-reinforced concrete surfaced with a brushed sand mix. In many instances, the caps, balusters, and copings exhibit surface cracks. In others, the underlying concrete has begun to crack, spall, or disintegrate.

Bannister with various small cracks, accumulation of moss.

All cracks and other defects in the sand mix surface of the pier caps and balustrades should be repaired by excising failing sand mix with a diamond blade and applying new sand mix.

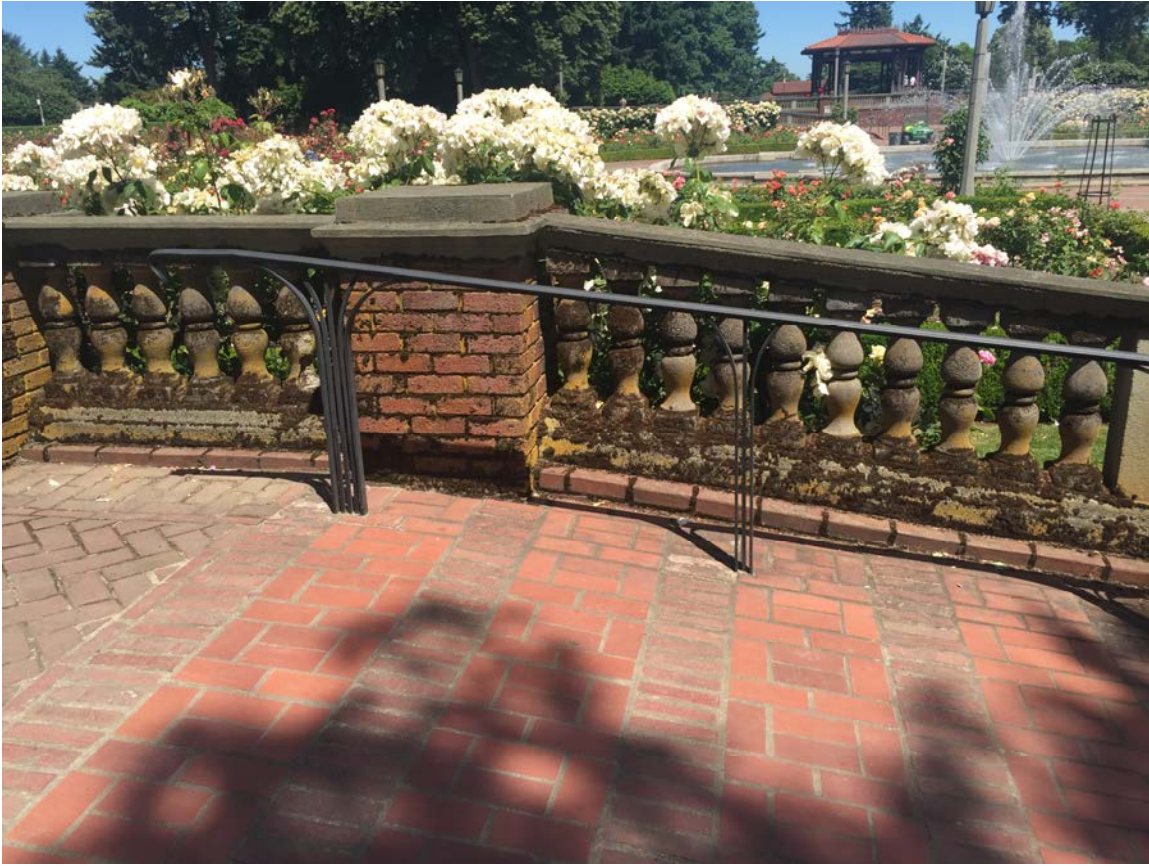
Balustrade with heavy accumulation of moss. Cracks in base of banister are evident by linear distribution of moss. Moss must first be removed in order to assess damage and make repairs.

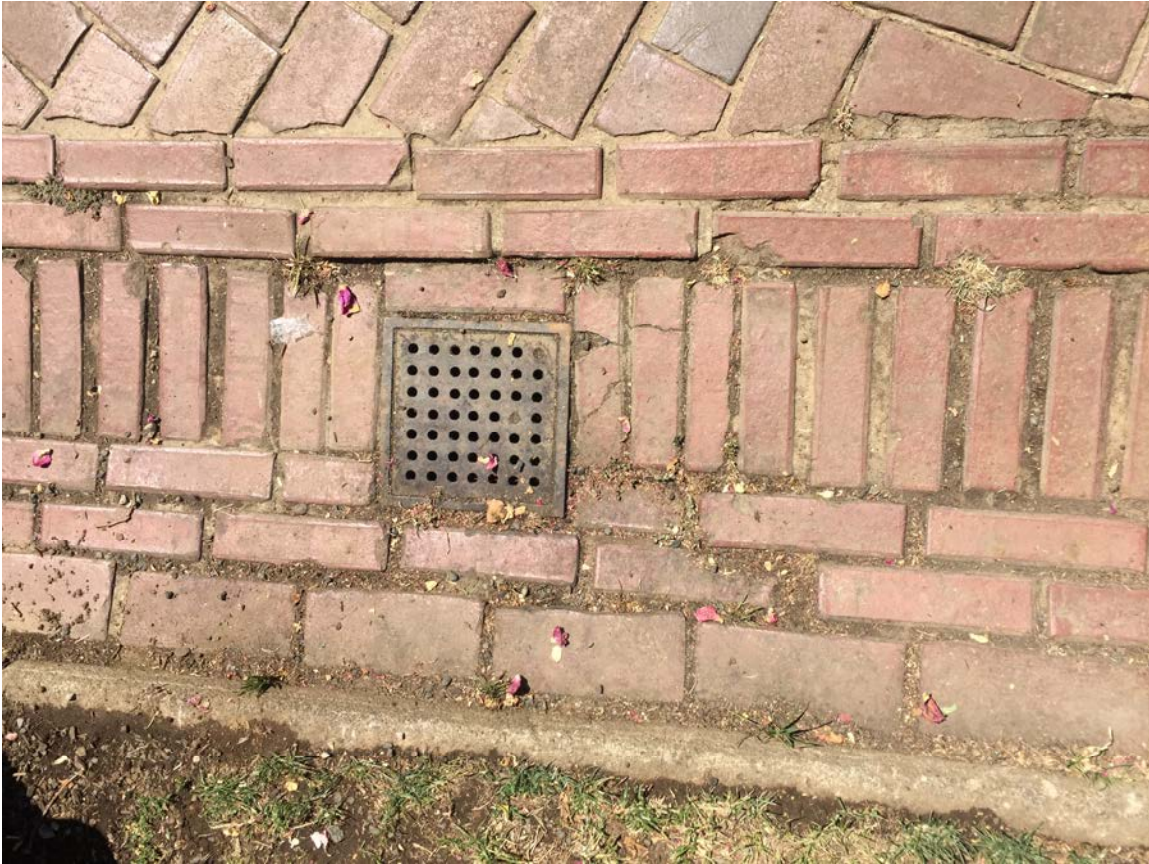
Some of the flatwork in the gardens, most notably in the brick-lined drains at the outside edge of the circuit around the fountain, have either sunk or raised slightly. These areas will require careful removal of existing brick and resetting to restore the original grade of the work. The existing brick is no longer available, so every effort should be made to remove existing brick without damaging it so that it can be reset. All work should be done with sand mix instead of mortar.

Border Gutter with metal drain. Note that brick to the left of the drain is lower than than the drain top. Repointing and, where necessary, regrading this brick will allow water to escape directly through drain instead of lingering or moving through defects in the masonry.

- a. All eroded and failing sandmix between bricks should be removed and replaced with new sandmix.
 - b. In all areas where the slope and contour of brickwork in the drains has been disrupted, the brick should be removed and reset to restore original slope and contour.
- These corrections will ensure that water will run directly to the existing drains without escaping into the gap between the brickwork and the slab or eroding the substrate underneath the slab.

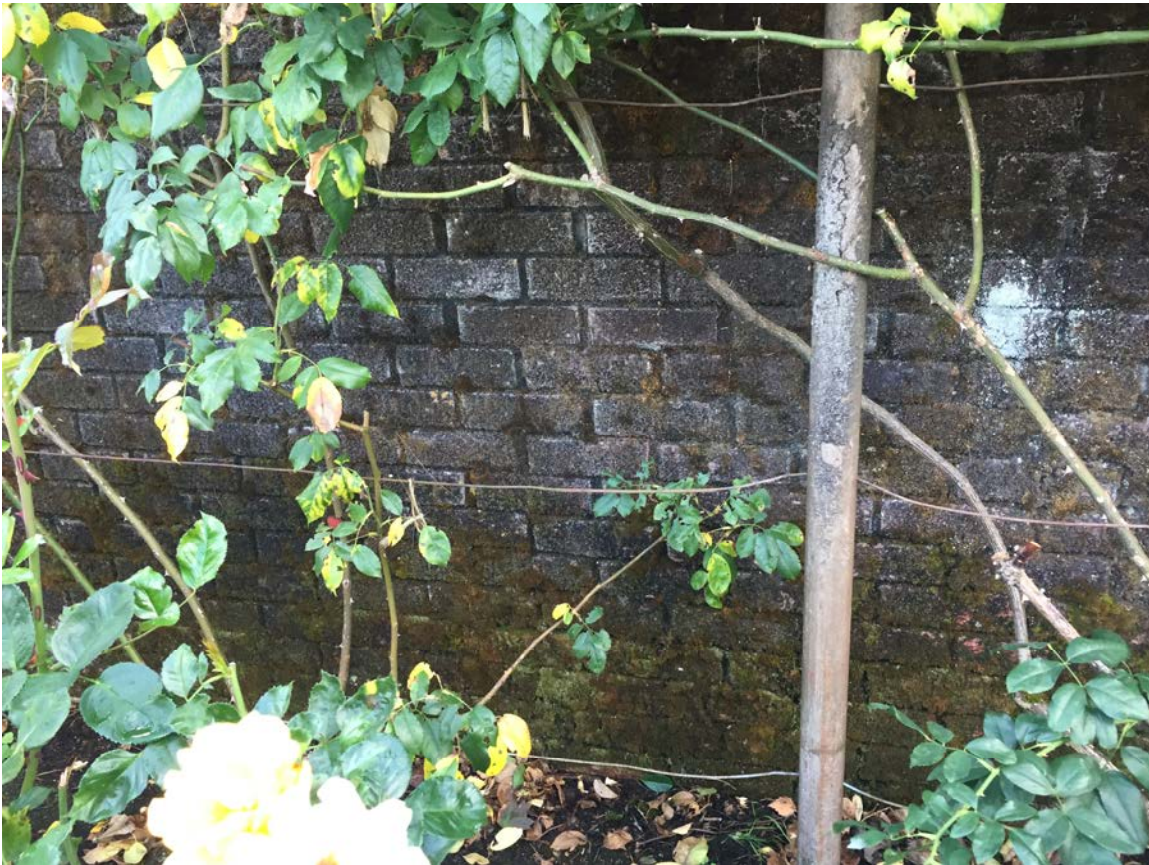
Heavy accumulation of moss on lower portion of this wall. The level of the soil at the base of the wall may be higher than originally intended. Ideally, brickwork begins above level of surrounding soil, atop a concrete or otherwise durable footing. Soil should be removed in a discrete area to see what the ideal level may be. Repointing should be done with a Type S mortar to 18" above ground to prevent deterioration.

All moss and organic material should be removed from existing masonry with the use of wire brushes and water. Masonry should not be pressure washed at any time. Masonry that is in disrepair or exhibits defects is especially susceptible to damage from pressure washing.

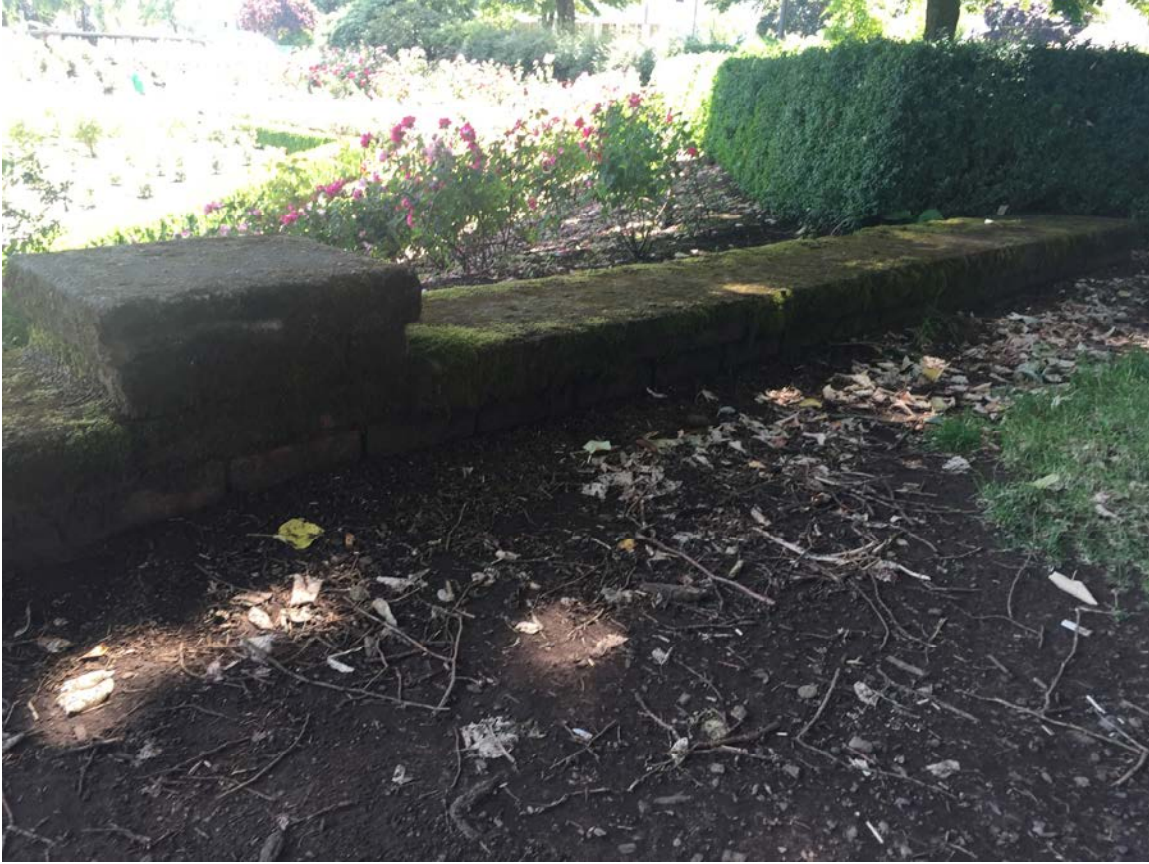
This portion of the outer wall is nearly overgrown with moss. It should be removed immediately. It is recommended that a trench of clear, crushed rock be applied next to the wall for at least 4" so that organic matter does not easily find itself onto the wall. This will extend the life of the wall after repointing.

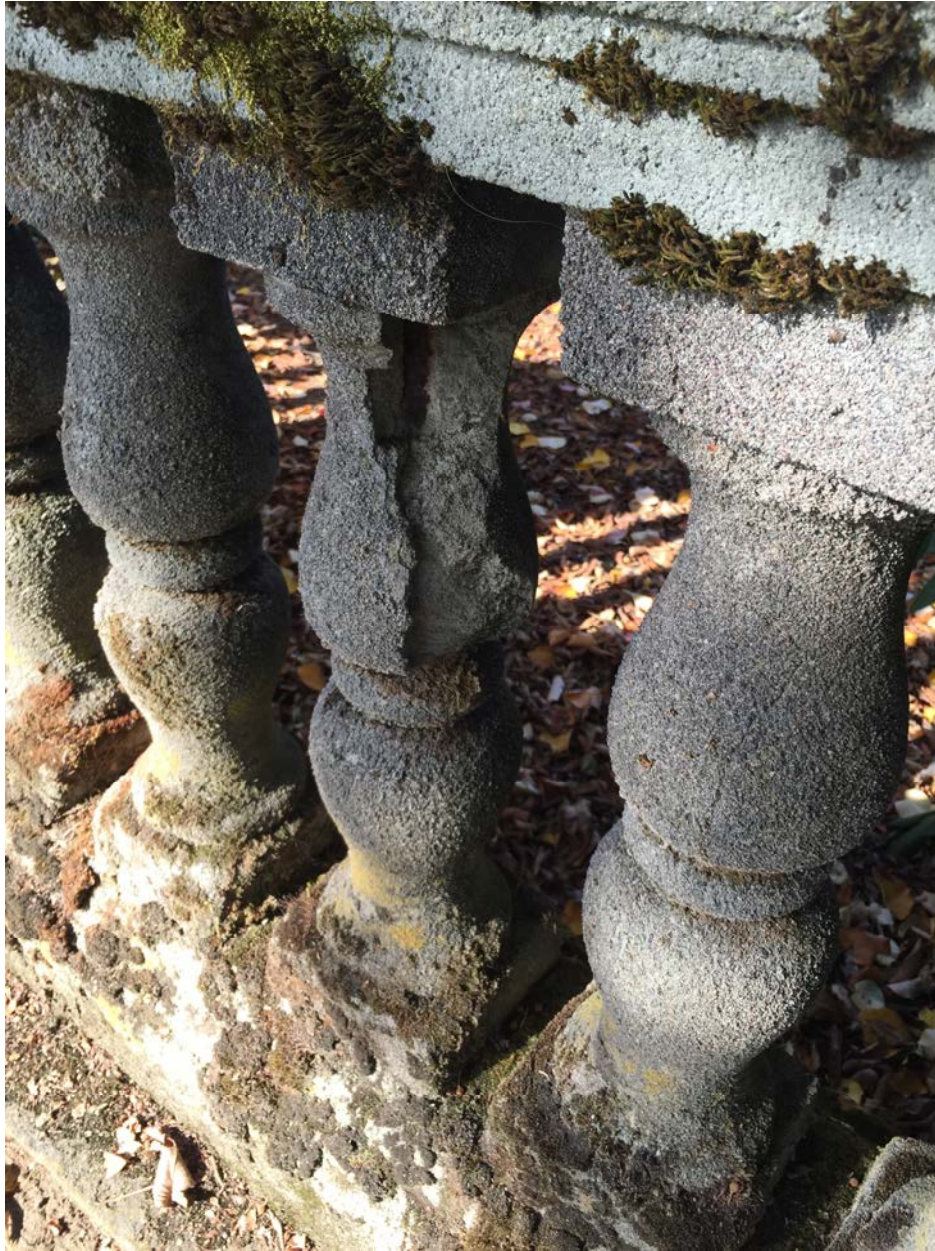
Pier caps, balustrade railings, and balusters should be repaired as soon as possible to prevent further decay and subsequent increase in damage to underlying structures and associated increase in cost.

We can repair open defects in pier caps, balustrade railings, and balusters for \$11,800. This work can be broken up into logical phases, repairing the largest defects first.

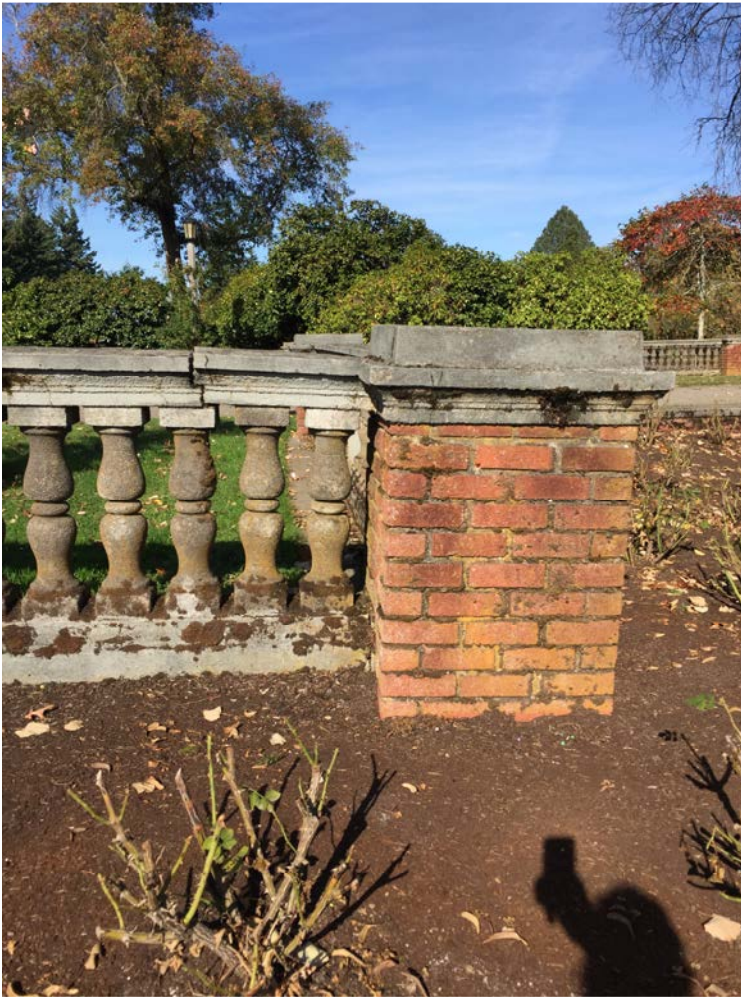
At the north side of the garden, east of the stairway that leads from the bandstand area down to the fountain, one of the brick piers has begun to sag, taking with it the balustrade.

An effort should be made to shore up the footing below this pier and to assess how best to restore it to its original position.

Assessment of the footing will require digging around the footing. This will destabilize the pier and accelerate the rate at which it is settling. For this reason, visual assessment of the state of the footing should be done only when the means to restore the footing and reset the pier are on hand.

If the pier can be restored to its original position and shored up from below, this work can be performed for \$2800-\$4500, depending on the extent of work required.
