MOUNT TABOR RESERVOIRS HISTORIC STRUCTURES REPORT

Reservoir Nos. 1, 5, 6 and 7

City of Portland Water Bureau

May 2009

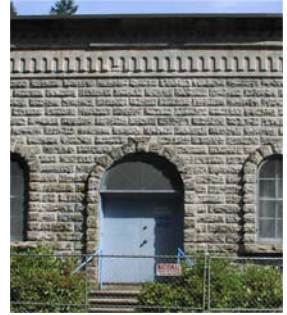
Condition/Observations: The non-original paired hollow metal main entry doors and frame are in fair condition, and need repainting. This opening is not scheduled for revision under Water Bureau Project No. 3366. The reservoir-side door and its hardware are weathered and are non-historic replacements.

Option A.2: Repair, Replace – Replace doors and frame with units matching the original design and materials

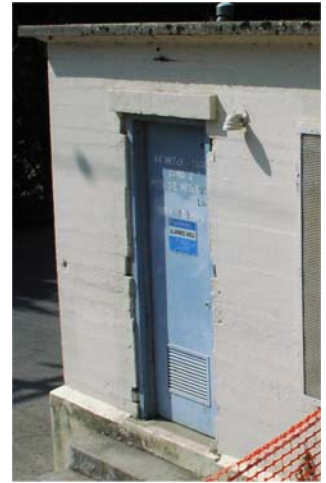
Condition/Observations: The structure is outside of the vehicle controlled area, and appears to receive vandalism as a result. The entry door frame is damaged at the head member, and there are damaged concrete edges around that opening.

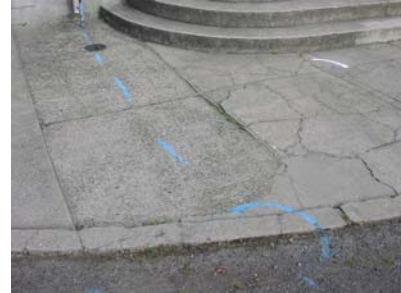
Condition/Observations: The walkway has some damaged areas, including broken slabs, corners, spalls, roughened surfaces and settlement. There does not appear to be much of a base remaining for the concrete slabs. The walkway is in better condition than at the other reservoirs.

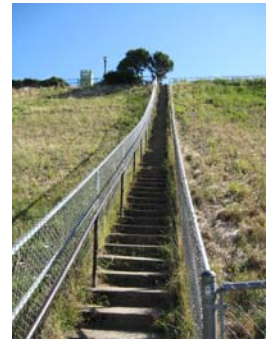
*Stairway, Reservoir 5
to Reservoir 6*

Condition/Observations: Portions of the stairway have been replaced or patched; the finish does not match original pattern. A low chainlink fence encloses the hillside and creates a corridor for the stairway. It was installed for structural reasons to limit pedestrian access and prevent erosion that regularly occurred on the west dam hillside face.

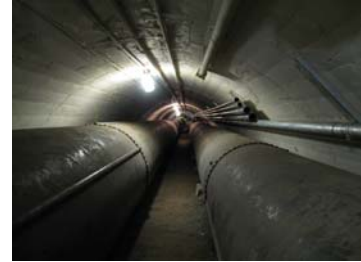
Condition/Observations: The concrete roof/ceiling appears to be in good condition. No evidence of leakage or serious concrete deterioration was observed. The floor was dry. The painted ceiling has peeled in some areas, and there is evidence of concrete patching. New conduit has been installed on the south wall in conjunction with Water Bureau Project No. 3366.

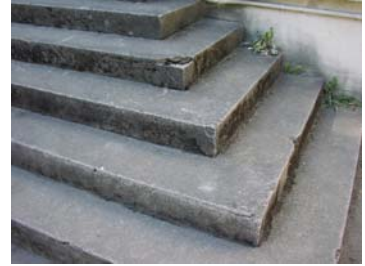
Condition/Observations: There is spalling at the steps. It appears that the steps have been recoated in the past, or were originally poured rough and finished with a topping coat, and that this topping is breaking up.

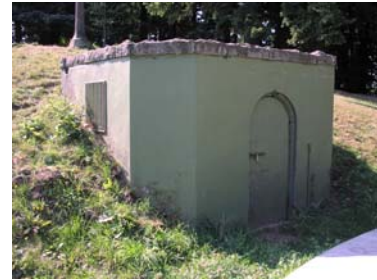
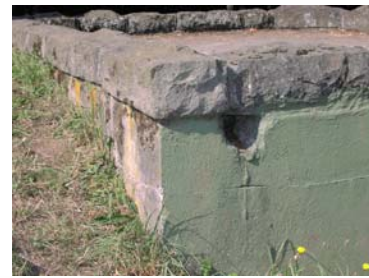
Reservoir 7 Building

Condition/Observations: The building is in fair condition. The drainage system is prone to clogging from tree debris. There is water damage evident (cracks and deposits) at the upper wall at the height of the roof deck. The stone roof curb has many deteriorated joints. The access door has non-historic hardware and intrusive security provisions. Part of the frame molding is missing. The wood louver vents are badly deteriorated.

Option A.1: Preserve and Repair – Repair wood door and frame, suitable hardware; repair wood louver vents where venting required; where not required provide protective overlay; repair stone and crack damage at roof and upper wall; remedy roof drainage
