ENVIRONMENTAL OVERLAY ZONE MAP CORRECTION PROJECT

VOLUME 3, PART C: Tryon Creek & Southwest Hills East, Natural Resources Inventory and ESEE Decisions

Discussion Draft
November 2019

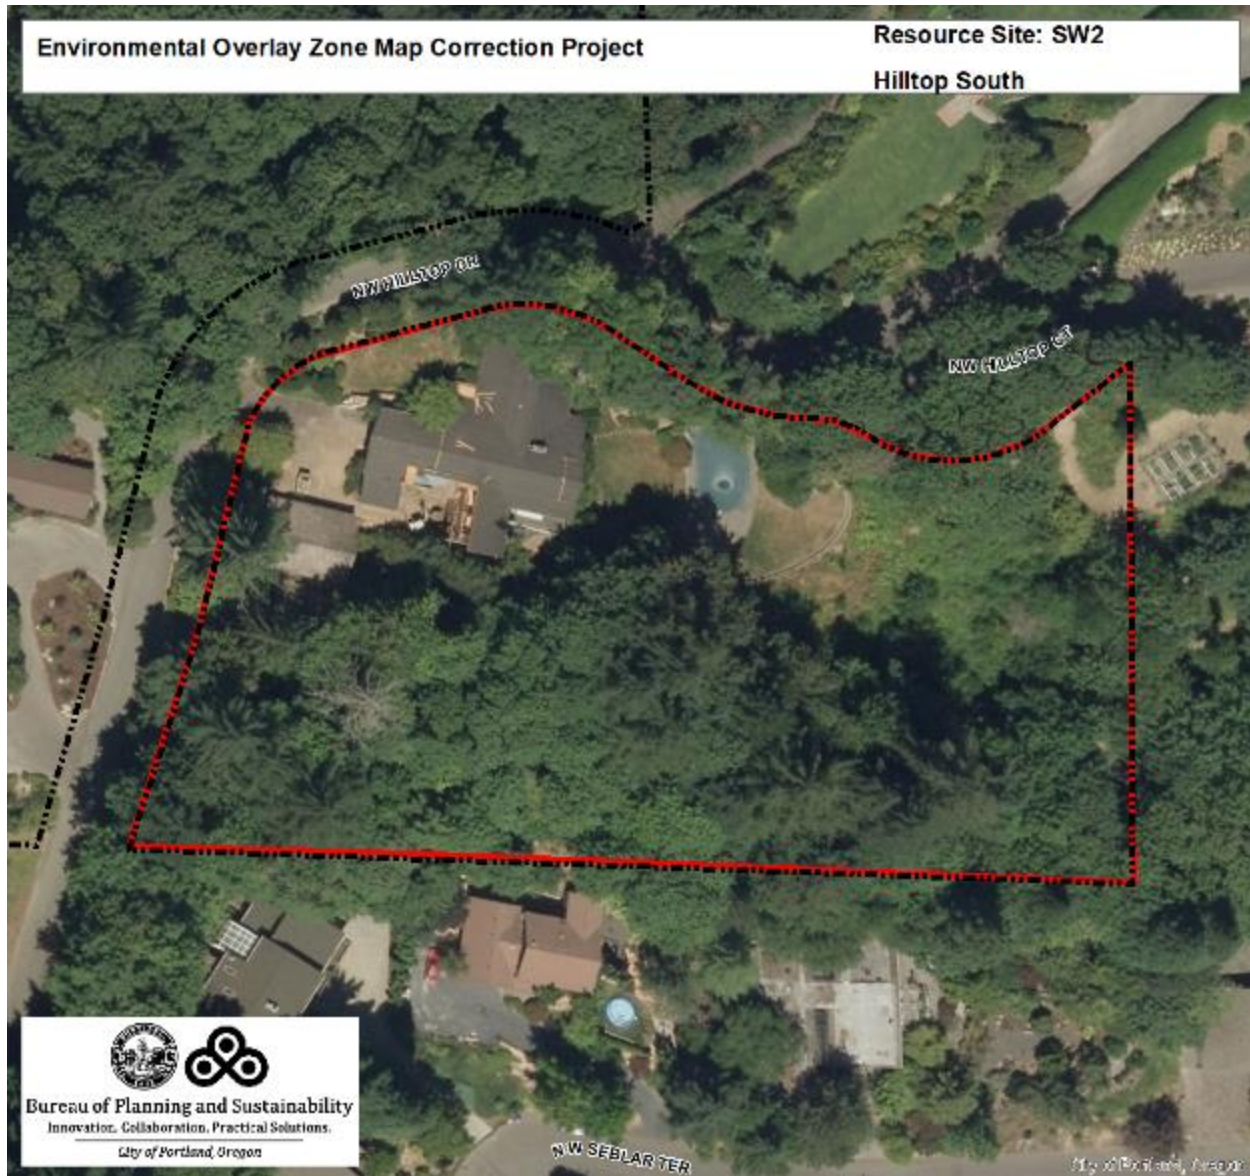
Resource Site No.: SW2 **Resource Site Name:** Sylvan D

Table A: Quantity of Natural Resource Features in Resource Site		SW2
		Study Area
Stream (Miles)		0.0
Wetlands (acres)		0.0
Vegetated Areas >= 1/2 acre (acres)		1.5
Forest (acres)		1.5
Woodland (acres)		0.0
Shrubland (acres)		0.0
Herbaceous (acres)		0.0
Flood Area*		0.0
Vegetated (acres)		0.0
Non-vegetated (acres)		0.0
Steep Slopes (acres)**		1.5
Impervious Surface (acres)		0.2
* The flood area includes the FEMA 100-year flood plain plus the adjusted 1996 flood inundation area.		
**Slopes are derived from LiDAR. Steep slopes are area with a slope greater than 25%.

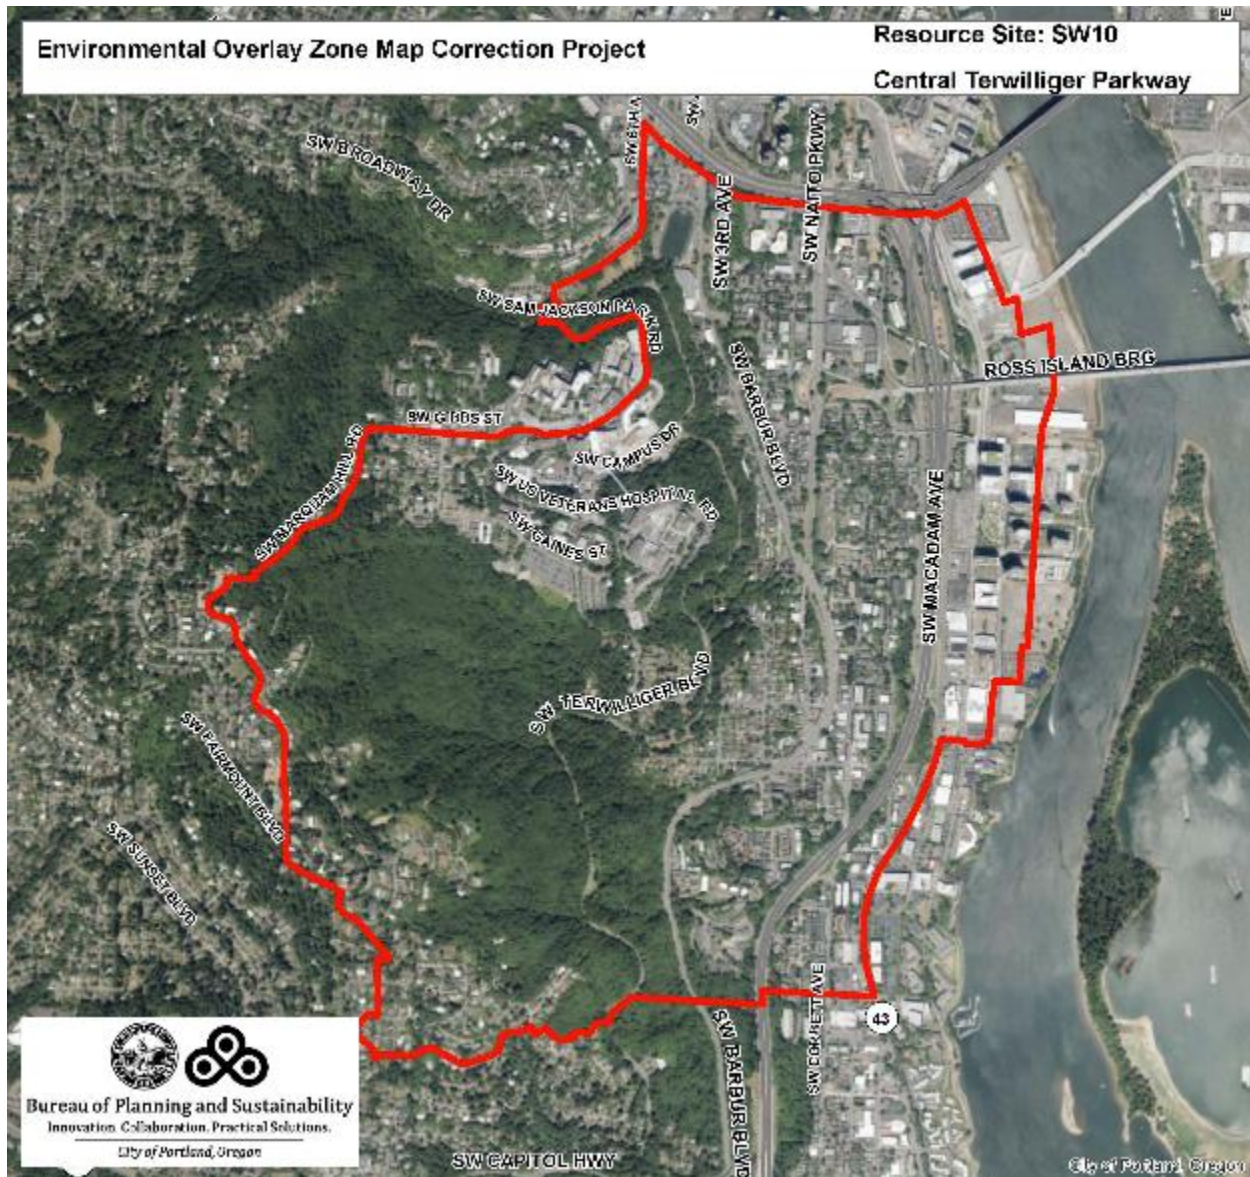
Resource Site No.: SW10 Site Name: Central Terwilliger Parkway

Table A: Quantity of Natural Resource Features in Resource Site SW10	
	Study Area
Stream (Miles)	1.7
Wetlands (acres)	0.1
Vegetated Areas >= 1/2 acre (acres)	438.8
Forest (acres)	356.7
Woodland (acres)	36.0
Shrubland (acres)	10.9
Herbaceous (acres)	35.2
Flood Area*	34.4
Vegetated (acres)	0.4
Non-vegetated (acres)	34.0
Steep Slopes (acres)**	567.4
Impervious Surface (acres)	491.6
* The flood area includes the FEMA 100-year flood plain plus the adjusted 1996 flood inundation area.	
**Slopes are derived from LiDAR. Steep slopes are area with a slope greater than 25%.

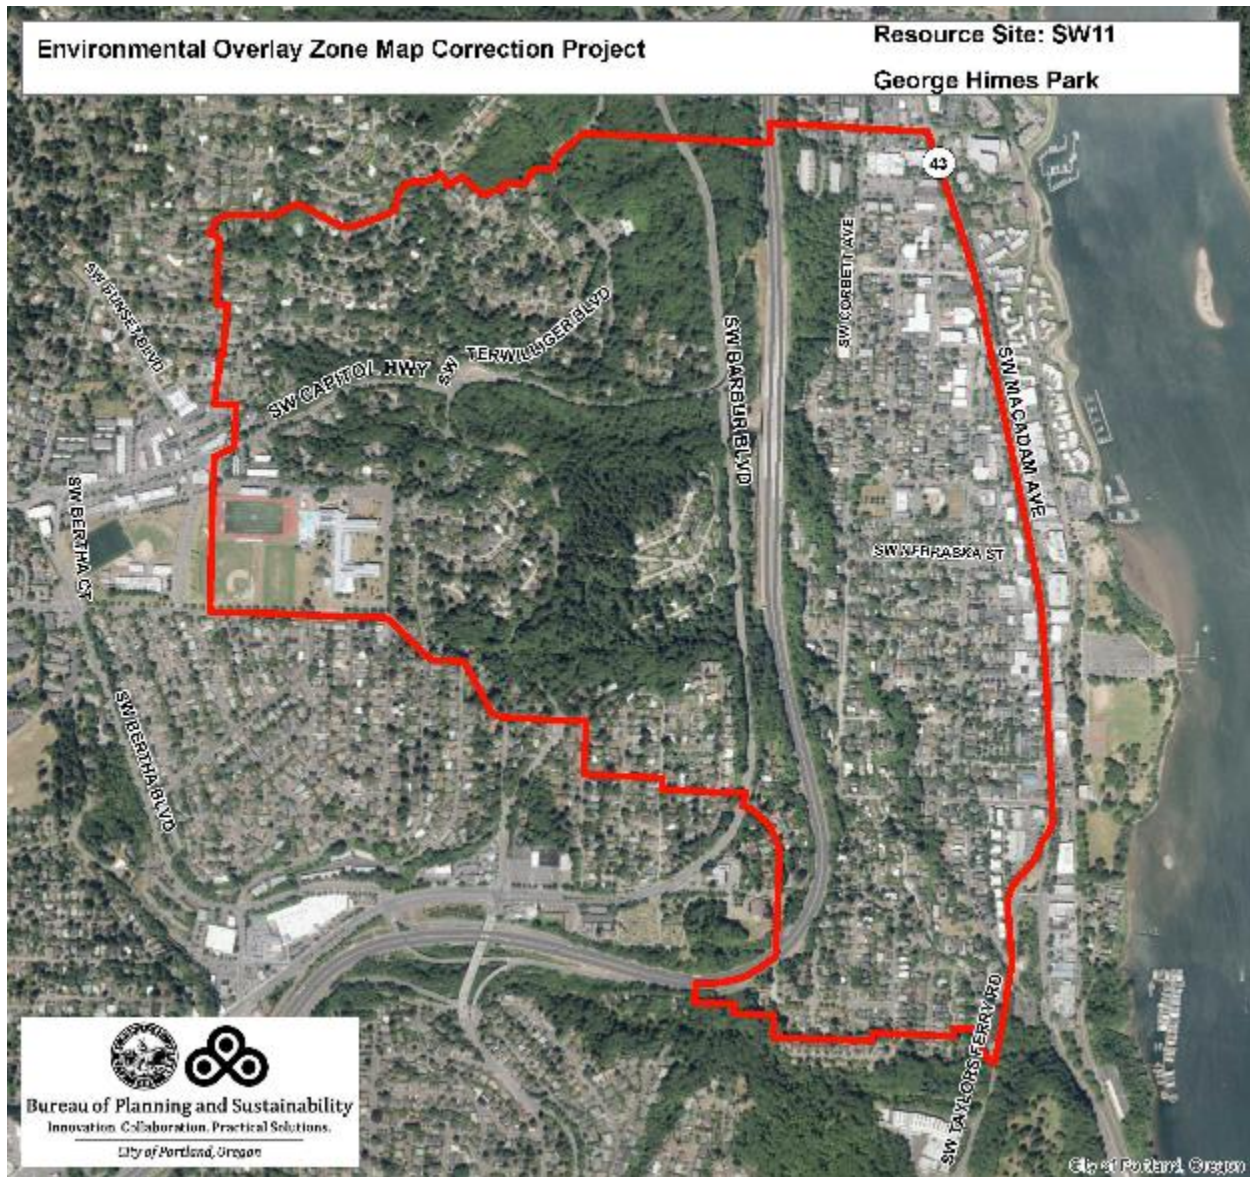
Resource Site No.: SW11 Site Name: George Himes Park

Table A: Quantity of Natural Resource Features in Resource Site SW11	
	Study Area
Stream (Miles)	0.4
Wetlands (acres)	0.4
Vegetated Areas >= 1/2 acre (acres)	198.5
Forest (acres)	178.1
Woodland (acres)	10.0
Shrubland (acres)	0.7
Herbaceous (acres)	9.7
Flood Area*	0.0
Vegetated (acres)	0.0
Non-vegetated (acres)	0.0
Steep Slopes (acres)**	290.1
Impervious Surface (acres)	256.3
* The flood area includes the FEMA 100-year flood plain plus the adjusted 1996 flood inundation area.	
**Slopes are derived from LiDAR. Steep slopes are area with a slope greater than 25%.

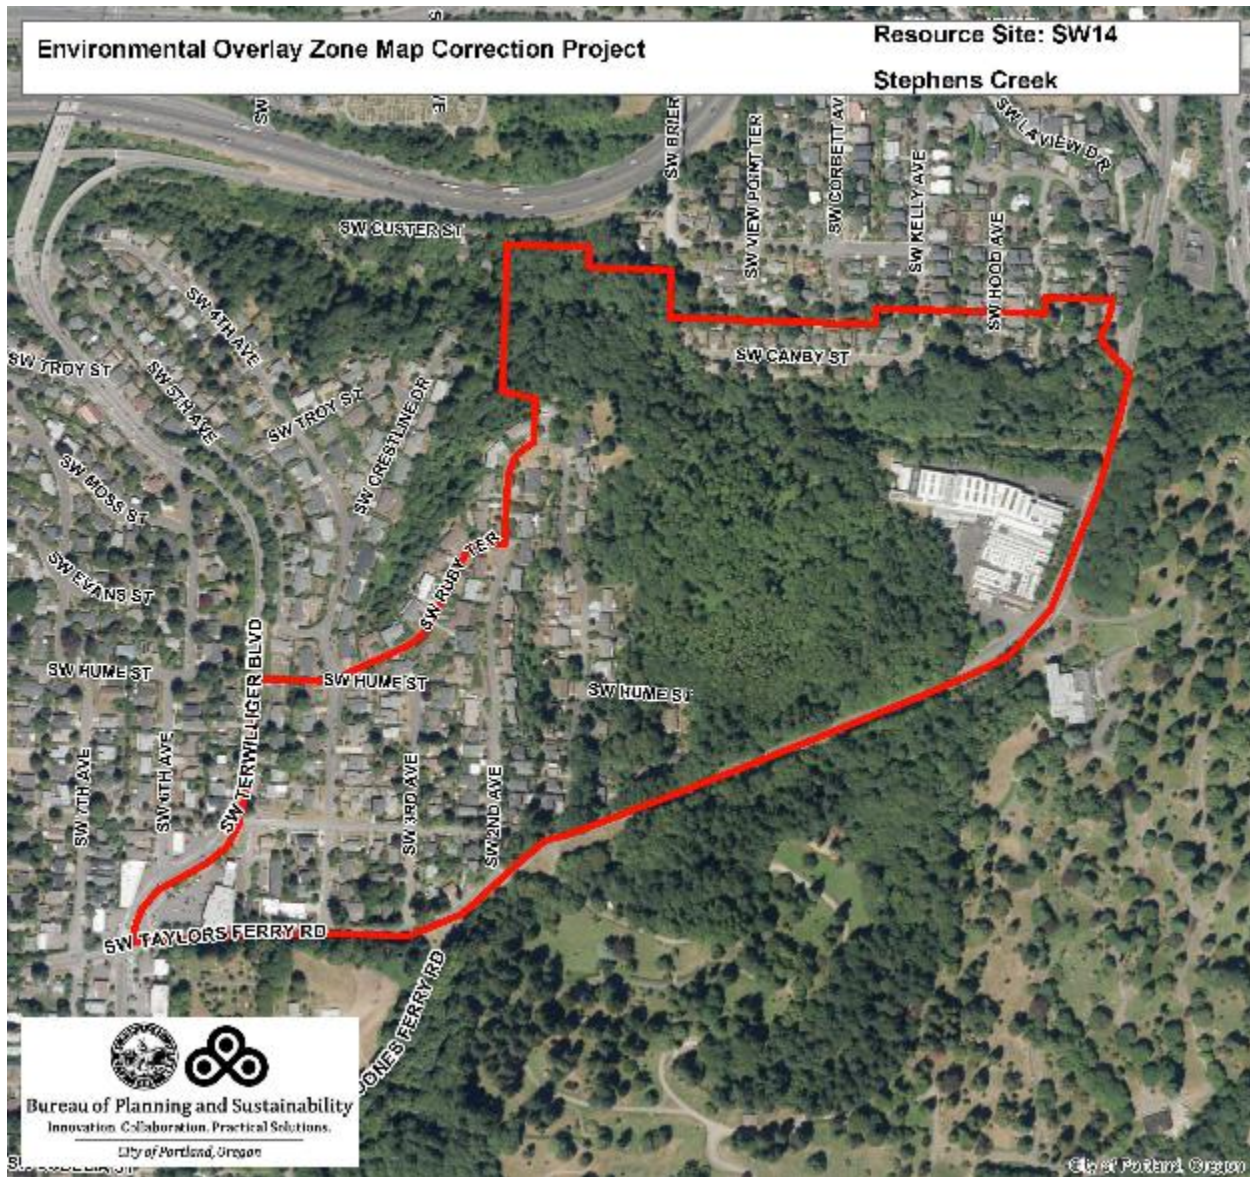
Resource Site No.: SW14 Site Name: Stephens Creek

Table A: Quantity of Natural Resource Features in Resource Site SW14	
	Study Area
Stream (Miles)	4.0
Wetlands (acres)	1.0
Vegetated Areas >= 1/2 acre (acres)	40.6
Forest (acres)	37.3
Woodland (acres)	2.5
Shrubland (acres)	0.0
Herbaceous (acres)	0.8
Flood Area*	0.0
Vegetated (acres)	0.0
Non-vegetated (acres)	0.0
Steep Slopes (acres)**	43.9
Impervious Surface (acres)	24.5
* The flood area includes the FEMA 100-year flood plain plus the adjusted 1996 flood inundation area.	
**Slopes are derived from LiDAR. Steep slopes are area with a slope greater than 25%.
