RE: Interim Lead Reduction Plan

Portland Water Bureau

Interim Lead Reduction Plan Update

April 19, 2017

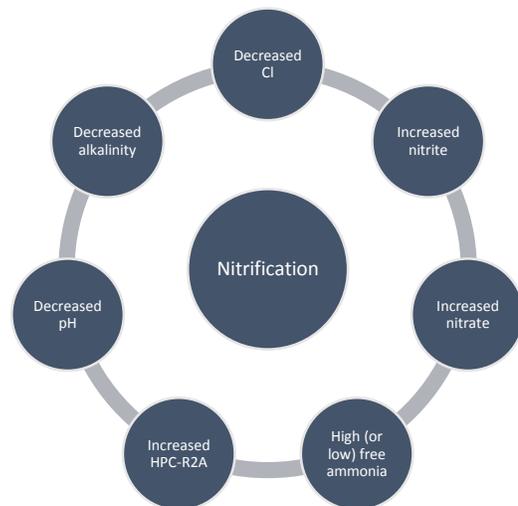
Figure 2. Impacts of nitrification on water quality.

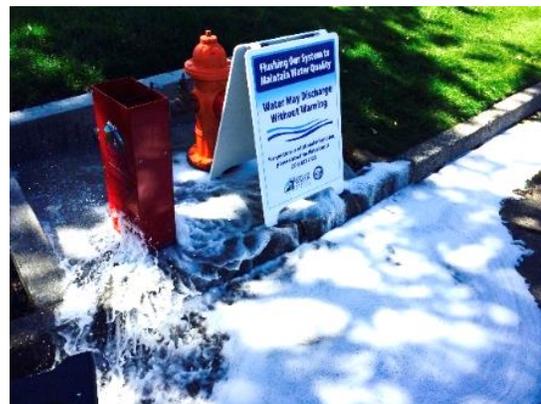
Figure 13. Autoflusher used in PWB's system.

PWB uses both conventional and unidirectional flushing (UDF) to improve water quality in the distribution system. Conventional flushing is typically utilized when bulk water turnover is desired. This is an effective tool for reducing water age, increasing chlorine residual, and responding to customer complaints. However, the effects can be temporary so it is not a good long term strategy for an area that has ongoing water quality issues. The PWB has both dedicated staff and two autoflushers (Figure 13) that perform conventional flushing in the system.

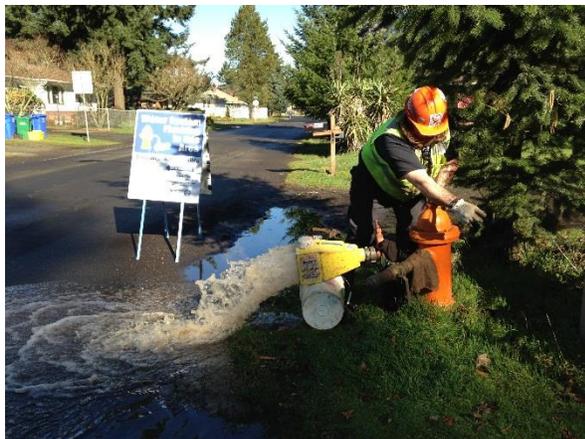
Figure 14. UDF in PWB's system.

As an unfiltered system, UDF is a very important tool for maintaining the cleanliness of the system. The overall goal of the UDF program is to achieve a scouring velocity to remove biofilm, sediment, and metal accumulations from distribution system pipes. In 2013, PWB's UDF program shifted from a systematic to a targeted program that focuses on areas in the system that have experienced water quality issues.

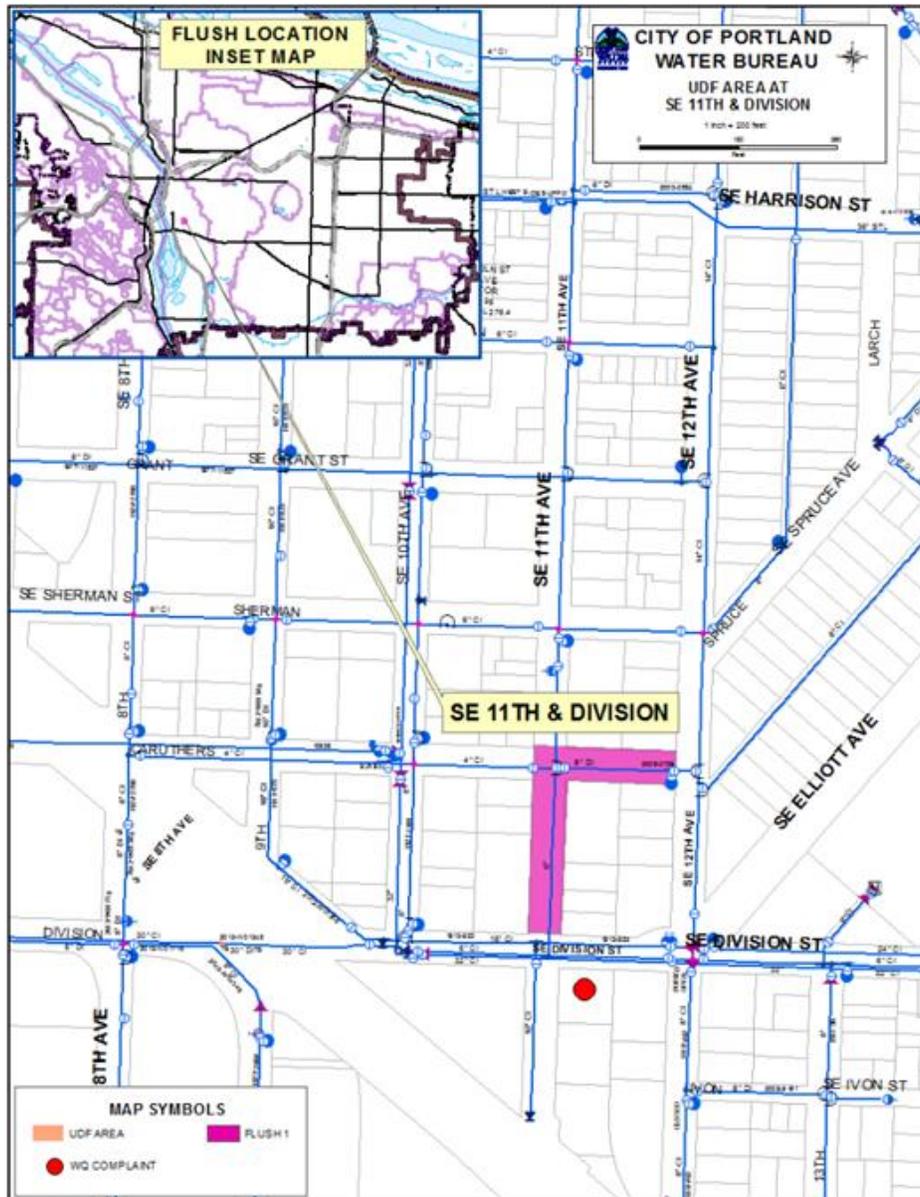
Figure 9. SE 11th & Division. The mains that were flushed are highlighted in pink.

- A fire systems contractor failed a fire flow test given by the fire department due to ‘debris’ in the line.
 - The flush area has numerous restaurants, bakeries, etc., so the flush occurred between 2am-5am. This decreased the potential for delivering dirty water to our customers. No issues were noted with the flush.
 - The fire systems contractor then passed phase 1 of the flow test.
