Process for identifying / prioritizing pedestrian needs

Identifying Network Needs

Crossing the Roadway: Gaps

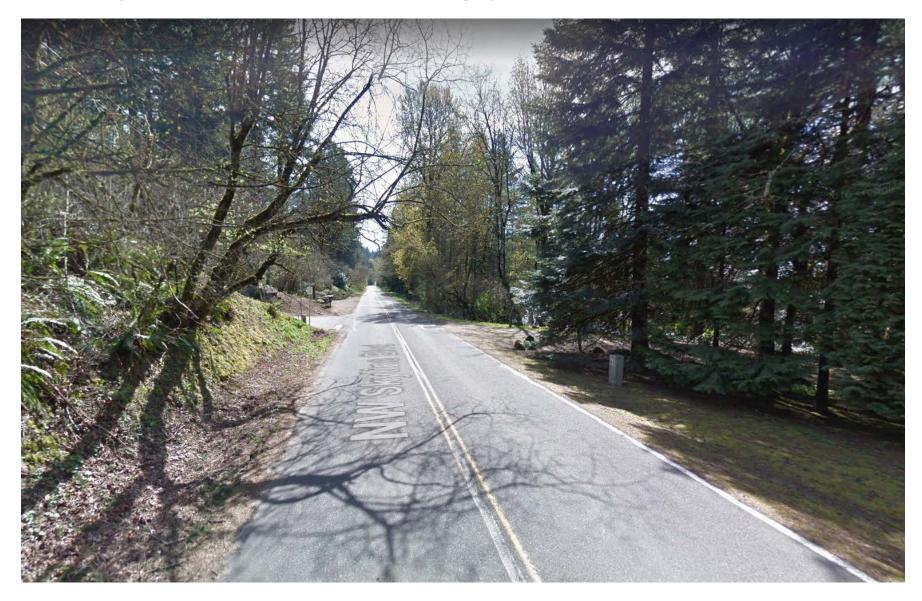
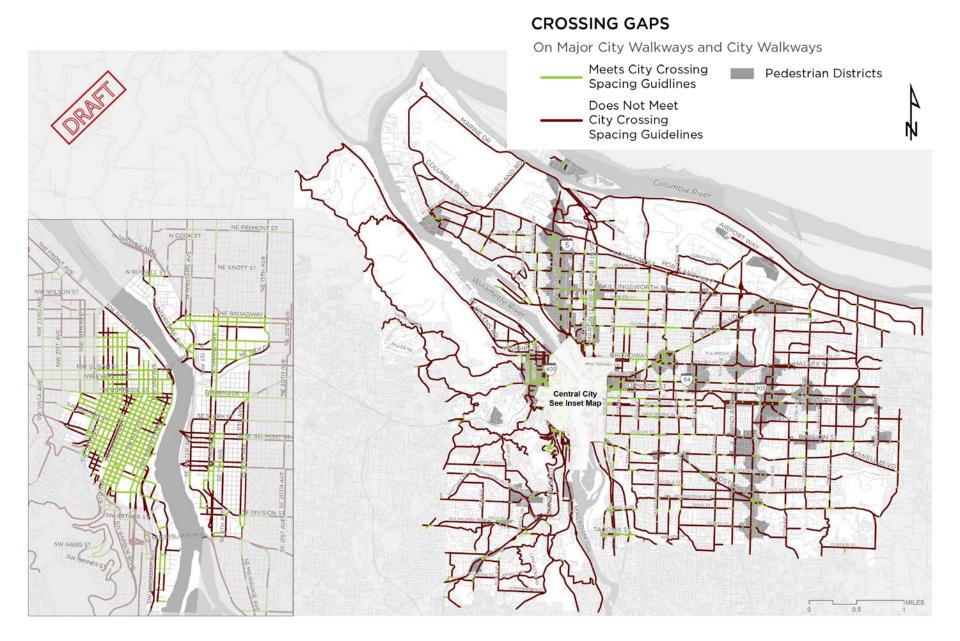
NW Skyline Boulevard, 9.28 mile gap

Inside Pedestrian Districts: maximum spacing of 530 feet between marked crossings (about two blocks)

Outside of Pedestrian Districts: maximum spacing of 800 feet between marked crossings (about three blocks)

- Approximately 3,520 new marked crossings needed
- 79% of the total miles of City
 Walkways/Major City Walkways have a gap
- Average gap length is roughly 1/3 mile

- Gaps are less prevalent in pedestrian districts than on streets outside of districts
- There are many marked crossings needed to meet the standard!

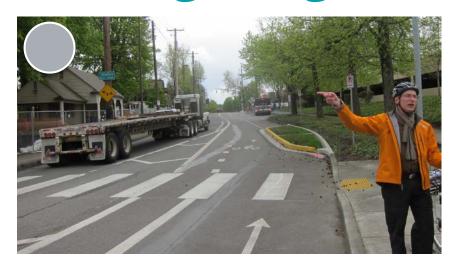
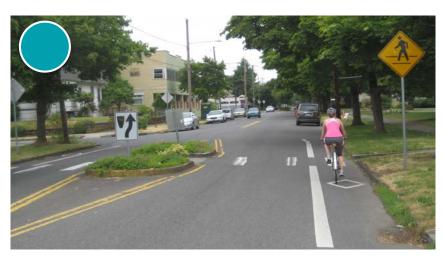
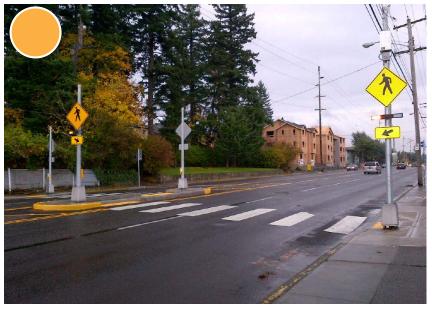
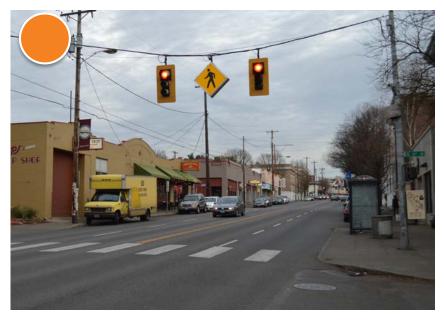
Crossing Design

- Marked Crosswalk
- Marked Crosswalk, island or curb extensions, enhanced signing and striping
- Marked Crosswalk and enhanced/active warning (islands and RRFB's)
- Marked Crosswalk and pedestrian hybrid or full signal

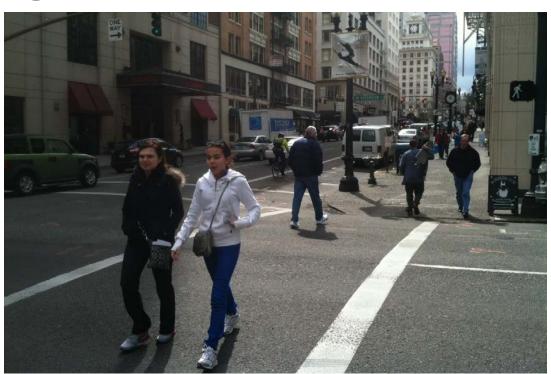
- 5% of existing marked crossing are potentially deficient
- 2/3 of existing marked crossings are at a signalized intersection

94% of deficient crossings are on a road that would need an RRFB to be considered sufficient

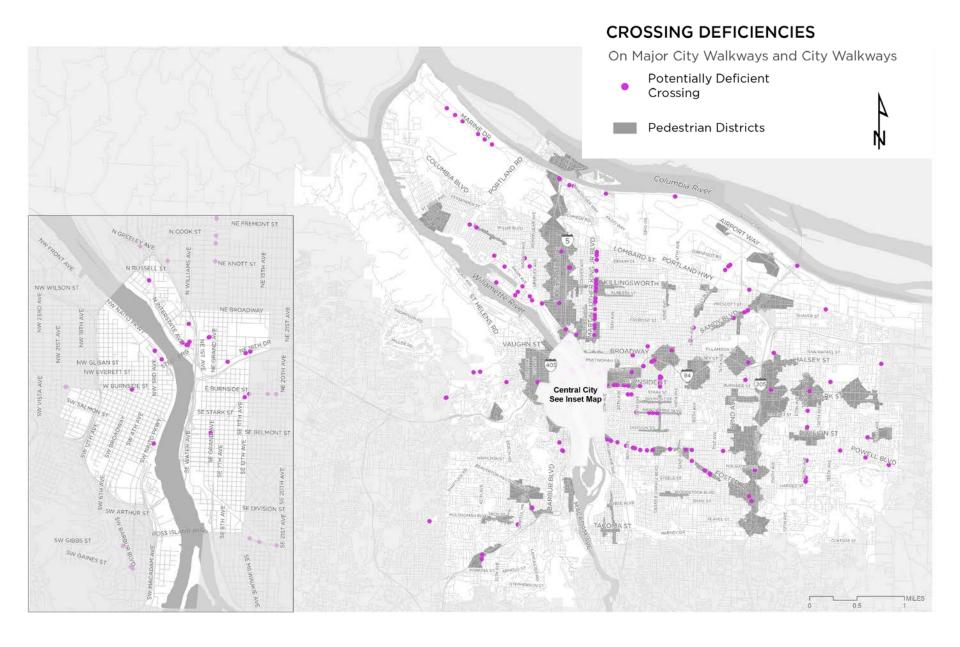
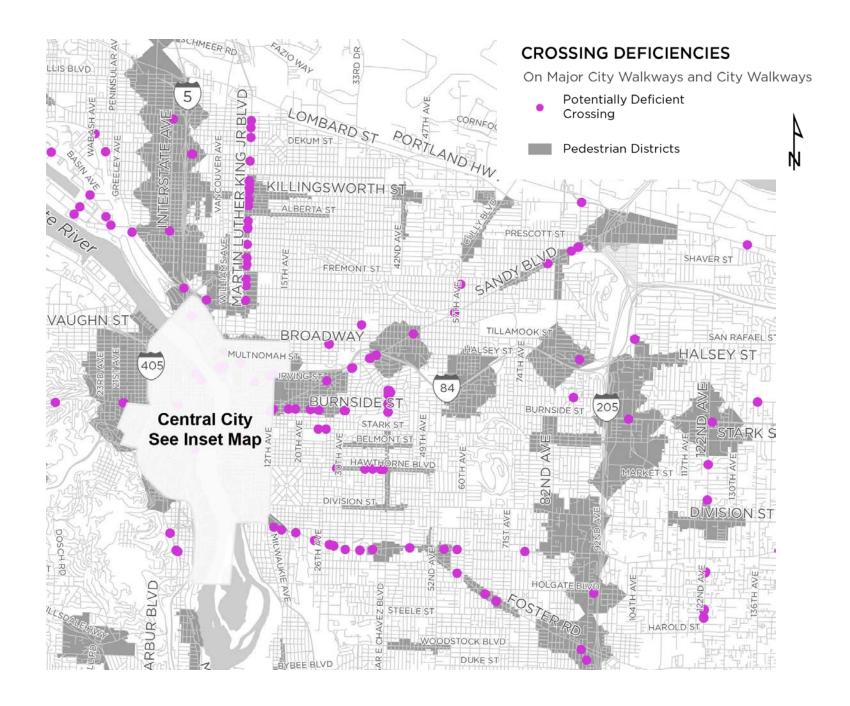
Desired Crossing Design for Roadway		
Existing Crossing Design	Blue: pedestrian refuge or curb extension	Orange: RRFB	Red: hybrid or full signal
Blue: pedestrian refuge island or curb extension	NA	87	1
Grey: marked crosswalk	3	105	9

- Deficient marked crossings are not as common as crossing gaps
- Most deficient crossings could be made sufficient with the addition of a signal, or by lowering the speed or traffic volume of the street

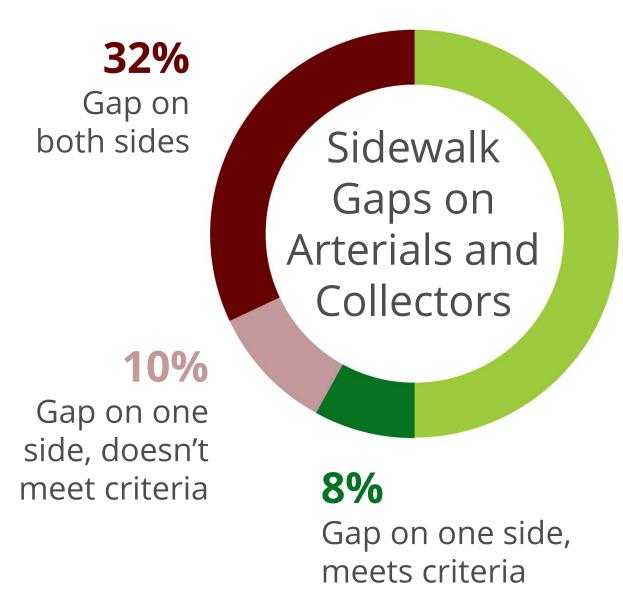
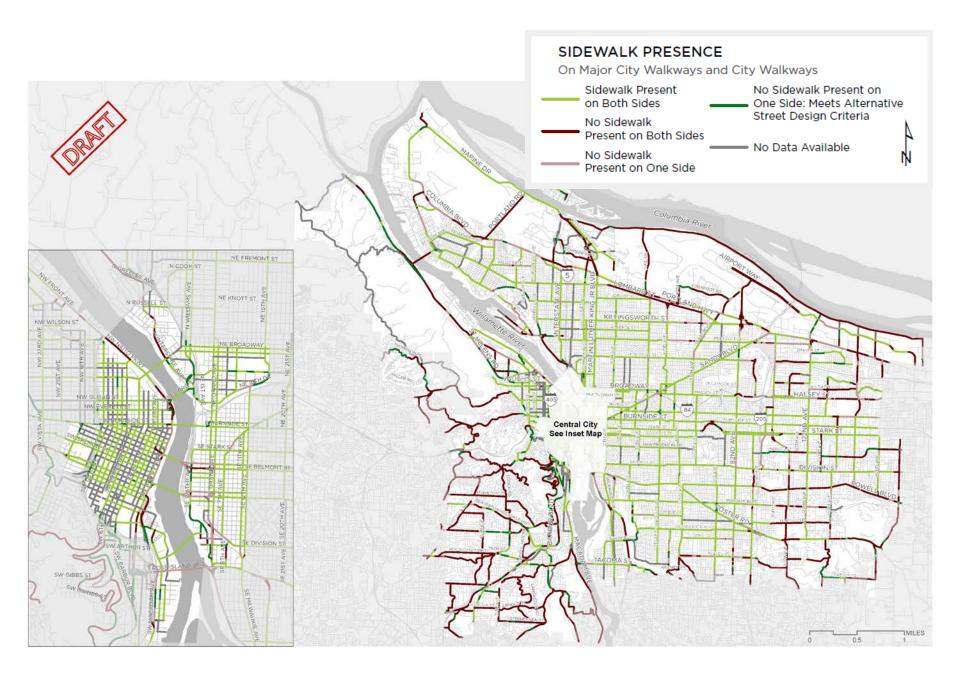
50%

Walkway on both sides

Most streets with gaps in the sidewalk have them on **both sides** of the streets

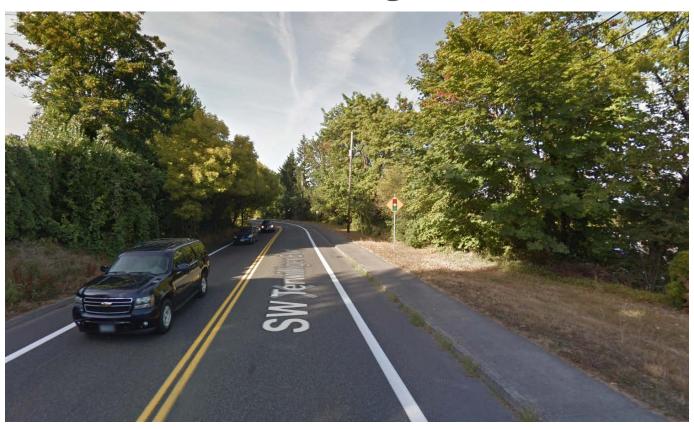
SW Terwilliger Boulevard

~45% of the streets with gaps on only one side meet Alternative Design Criteria

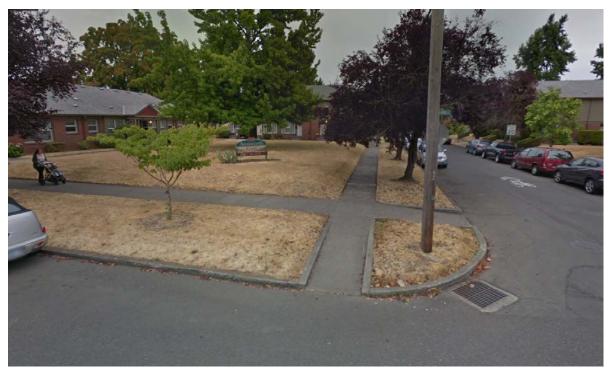
N Concord Ave between Ainsworth and Rosa Parks (neighborhood walkway in a pedestrian district)

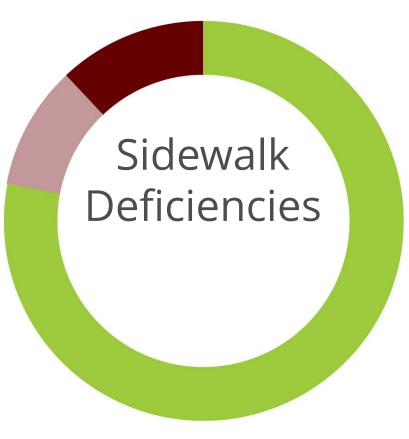
22% of streets with existing sidewalks have a deficient clear zone width on **one or both sides** of the street

12%Deficient on both sides

10%
Deficient on one side

78% Sidewalk is

6' or wider

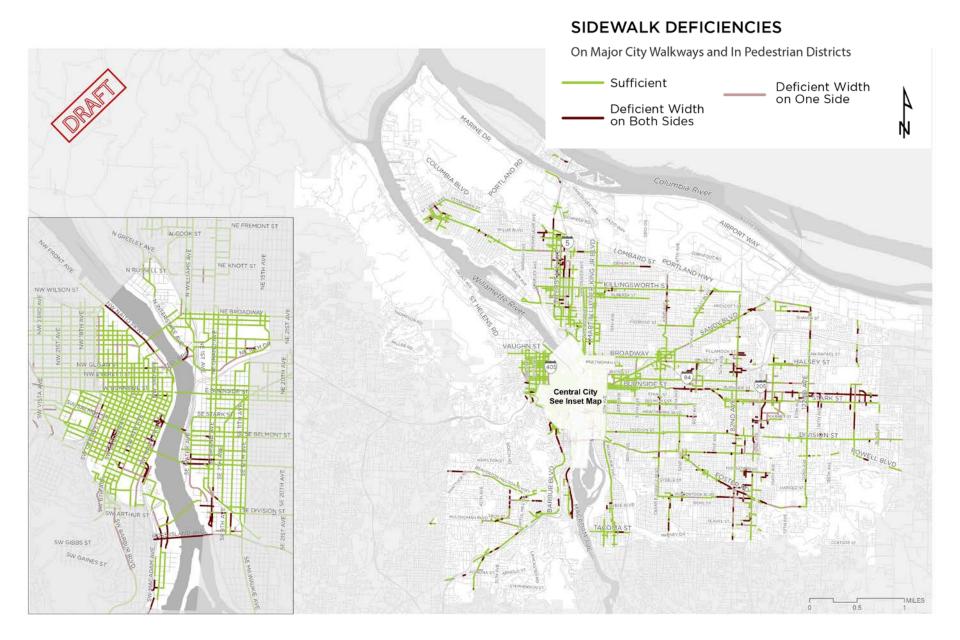
- City Walkways and Major City Walkways within pedestrian districts have the lowest rate of sidewalk deficiency, however that is based on a 6' width
- Neighborhood walkways are more likely than City Walkways to have a sidewalk that is too narrow
