Gabriel Weiss
Stonemason
CCB#161243
4115 SE 30th Ave
Portland, Oregon
97202

10/4/15

Assessment of Masonry in the Peninsula Park Rose Garden

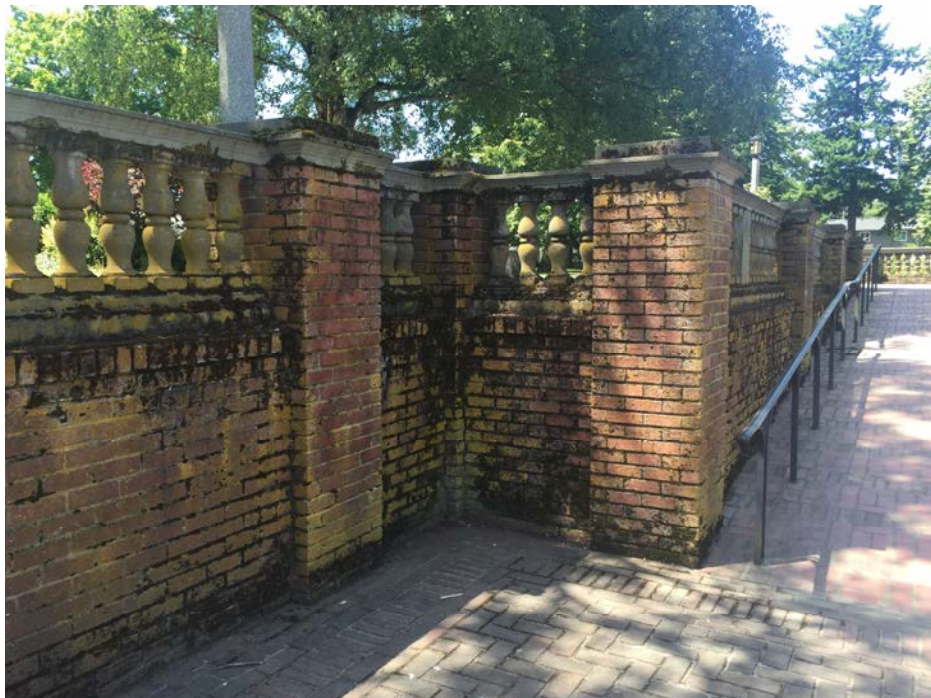
Heavy accumulation of moss on vertical wall below balustrade; moss must first be removed with a wire brush to prevent accelerated decay and to assess relative need for repoint.

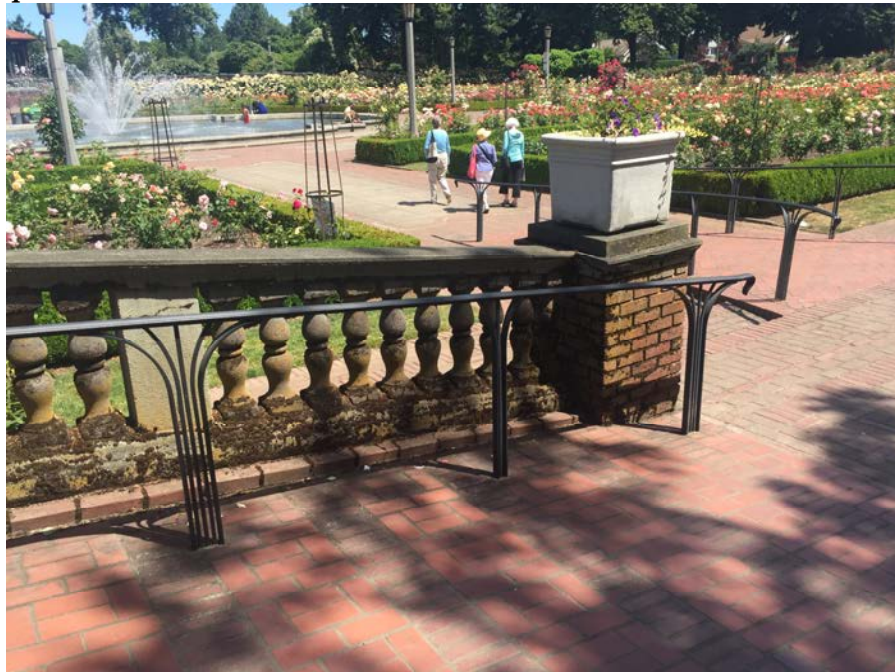
Balustrade with heavy accumulation of moss. Cracks in base of banister are evident by linear distribution of moss. Moss must first be removed in order to assess damage and make repairs.

All cracks and other defects in the sand mix surface of the pier caps and balustrades should be repaired by excising failing sand mix with a diamond blade and applying new sand mix.
