MOUNT TABOR RESERVOIRS HISTORIC STRUCTURES REPORT

Reservoir Nos. 1, 5, 6 and 7

City of Portland Water Bureau

May 2009

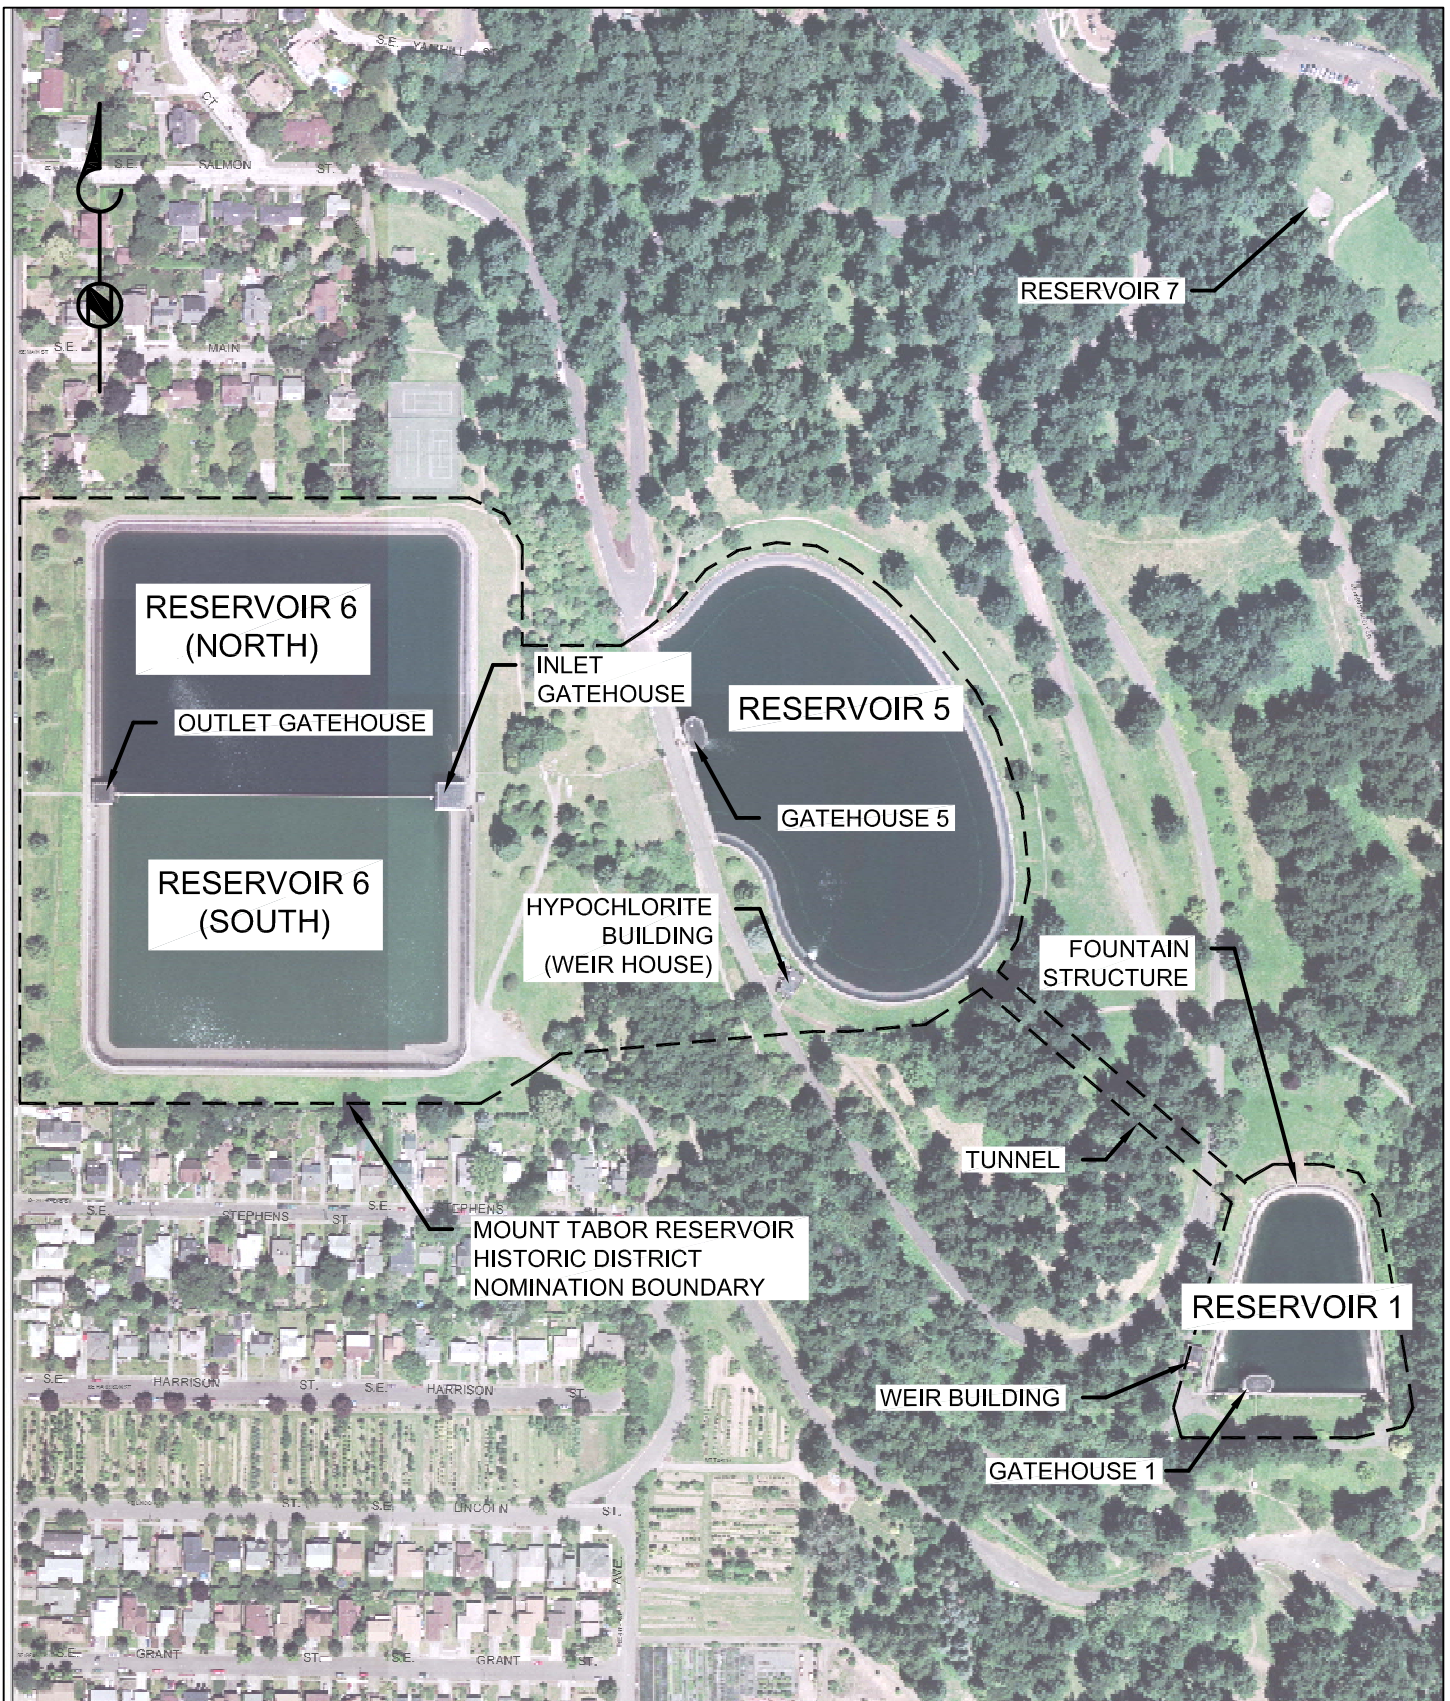
FIGURE 1 - SITE PLAN
MT. TABOR HISTORIC
STRUCTURES REPORT
PORTLAND WATER BUREAU
PORTLAND, OREGON

The Historic District boundary, including structures and other features, is shown in Figure 1, Site Plan.

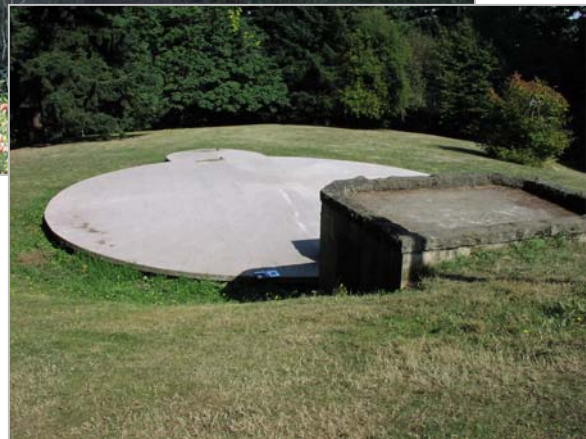
Reservoir 7 – Building

The building is located just south of the tank, and is partially dug into the hillside. It is a concrete building, rectangular in shape except for chamfered front corners. The building is approximately 14 feet wide by 11 feet long and 9 feet high, and has 10-inch thick board formed walls. The concrete roof is enclosed with a single course of rough-faced basalt and slopes to the southeast. There is a recessed drain collector box and through wall leader. The building has vent openings on each side and a single arched door on the front (north). The east vent is covered with plywood while the west vent retains its wooden louvers. Both vents have exterior security gratings. The arched door is constructed of vertical planks, has replacement hinges and a replacement surface-mounted slide bolt.
