Calculation Book Report

Calculation Book No. 440 **Standard Drawing No.** P-440

Drawing Title: 14' Asphalt Local Speed Bump

Split Speed Bump

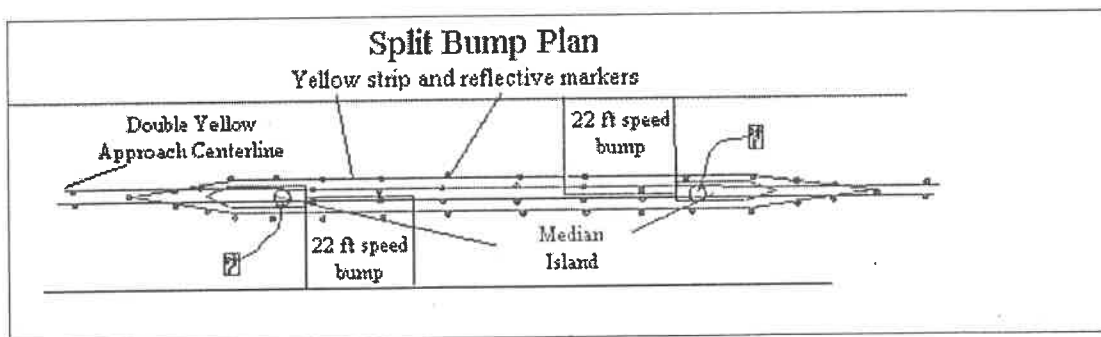
The device was placed approximately 200 feet west of the all-way stop. The first part of the testing was for safety. Concerns of whether automobile drivers would violate the device and chicane between the bumps were raised. Twenty-four hour time lapse video equipment was placed to record driving patterns over the bump.

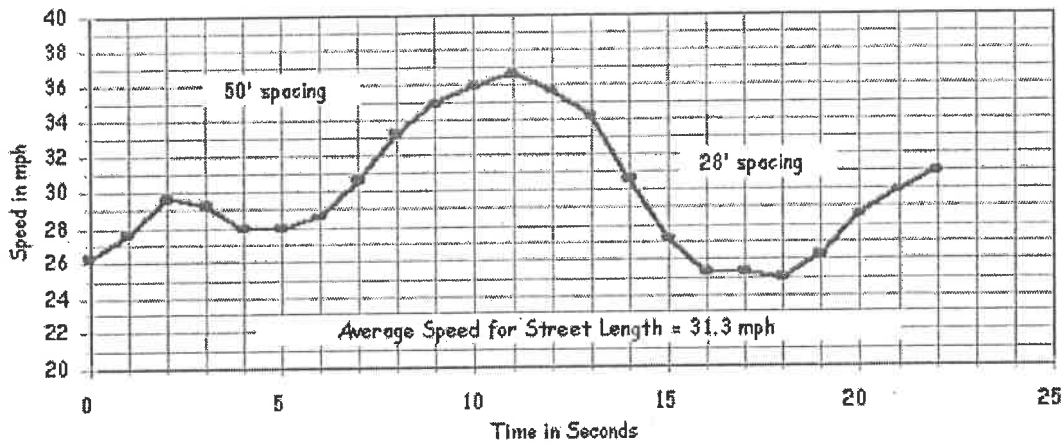
Engine 41 Eastbound - Average

SE Market Speed Bump Test

Both vehicles were able to travel the length of the street at speeds between 29 and 31 mph. The vehicle speeds through the 50 foot off-set spacing were 26 mph to 30 mph. Between the 28 foot off-set spacing, speeds were 20 mph to 26 mph. It was found that the actual time lost was no more than 1 to 2 seconds for the largest of the vehicles.

In reviewing the data for the test, it was noted that the slowest speeds, and therefore the most time lost, were at the off-set speed bump with the 28' spacing. The speed for the off-set speed bump with the 50' spacing never went below 25 mph.

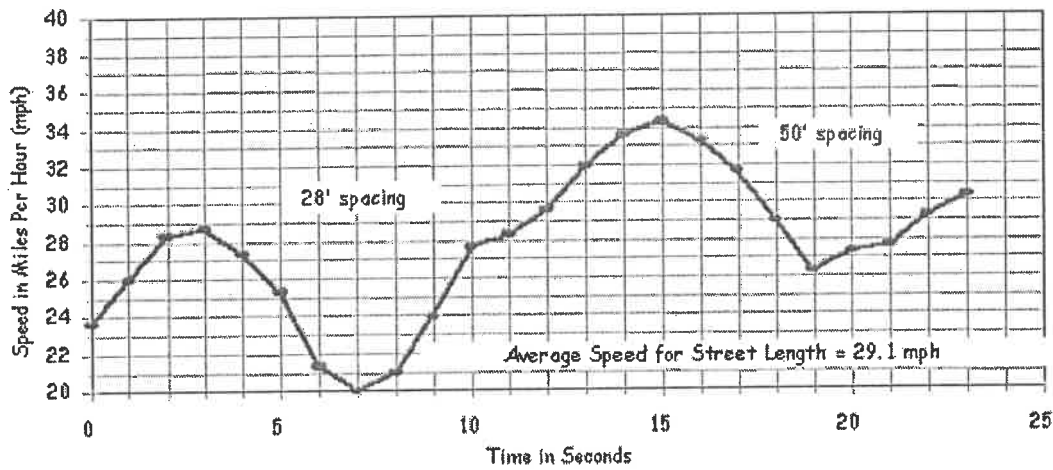
Engine 41 Westbound - Average

SE Market Speed Bump Test

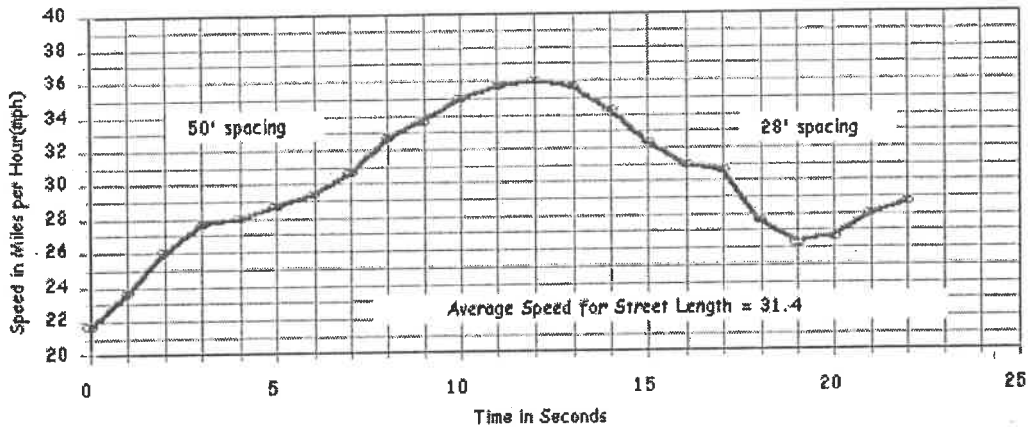
Truck 41 Eastbound - Average

SE Market Speed Bump Test

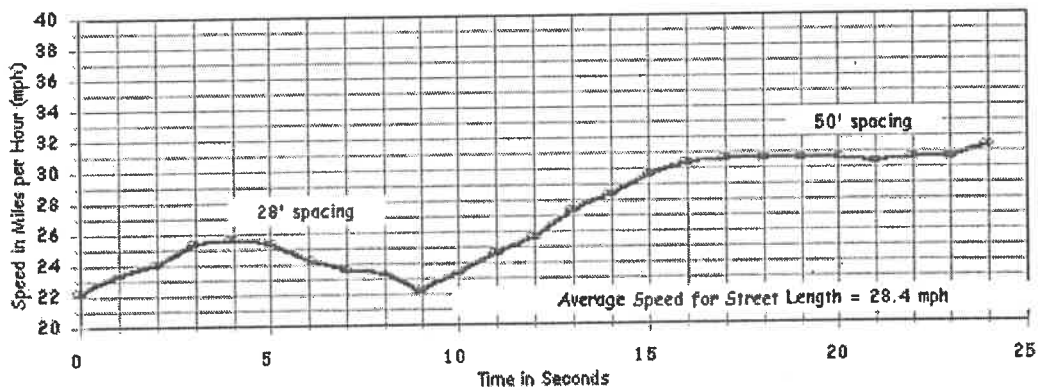
Truck 41 Westbound - Average

SE Market Speed Bump Test

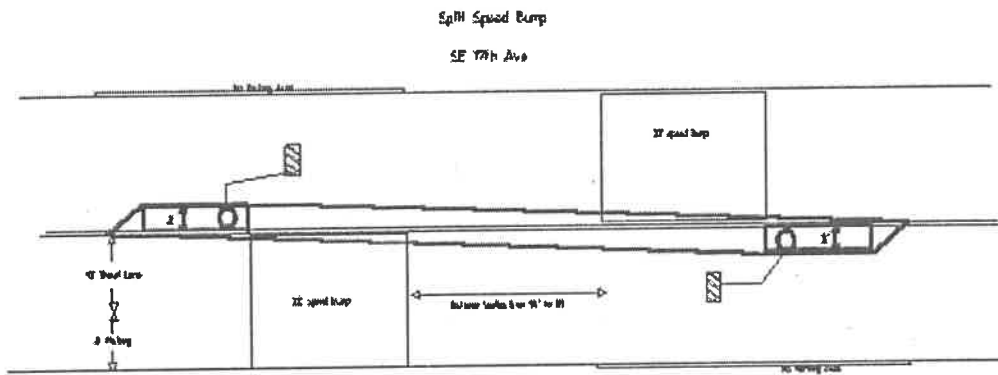
The design on the split bumps for this narrower street required some lane adjustments to maintain a minimum 10' lane through the device. Because of the width restriction on SE 17th, parking was removed for 30' opposite each of the split bumps. This incorporated both the 22' length of the bump half, and 7 feet for the approach island. These islands were only 2 feet wide, and set in such a way as to maintain the 10' travel lane. The distances between the bumps ranged from 50' to 85'.

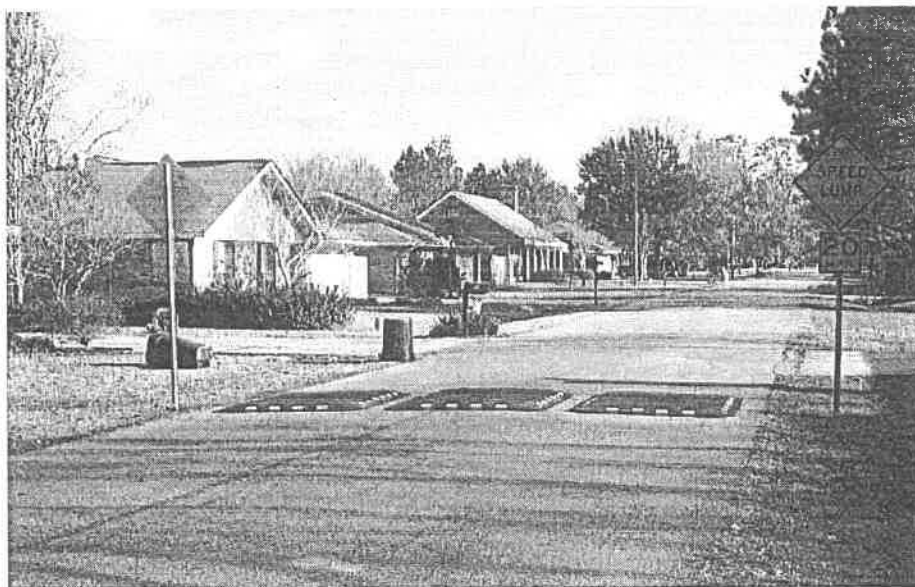
Photo 1. Speed Cushion, Lafayette, LA.

Compounding the issue of track width was the common use of dual rear wheels for heavier vehicles like transit buses and fire trucks. Dual rear wheels in heavy vehicles mean the clear space between the wheels of large vehicles more closely matches the track width of sedans and sport-utility vehicles common in the U.S. Finding a speed cushion wide enough to slow most private vehicles and yet narrow enough to permit fire trucks and transit vehicles to pass easily, without overloading those heavier vehicles' rear axles proved difficult. Also, the use of speed cushions means there are intentional gaps, or channels, between devices in a multi-device installation (see Photo 1).

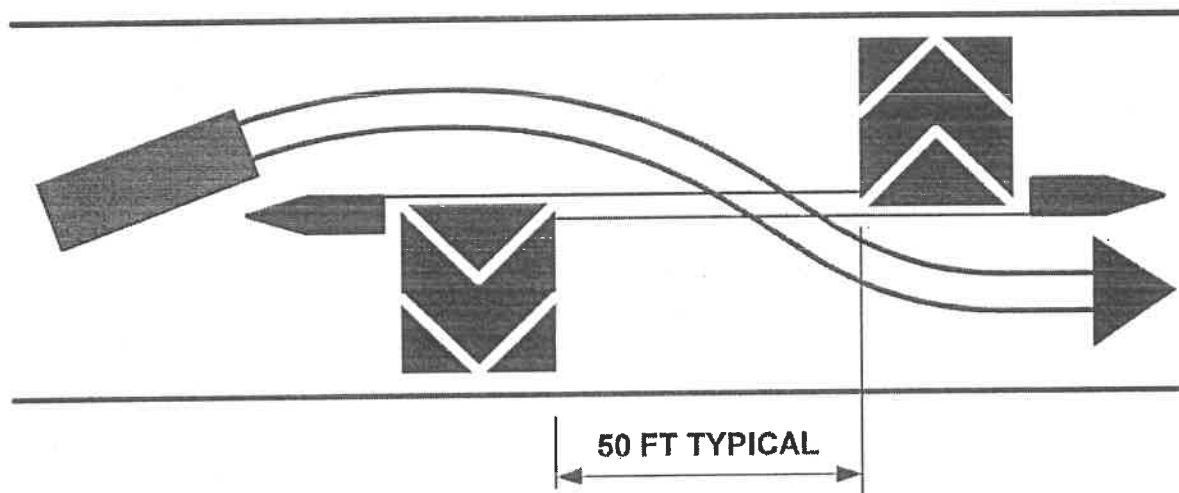
Figure 1. Offset Speed Table with Islands and Emergency Response Path.

In 1997 PDOT began testing an alternative to the speed cushion concept. PDOT'S design used a standard speed table that was constructed across only half of a street. The second half of the speed table was constructed downstream of the first and in the opposing lane. As emergency equipment is able to use any portion of the roadway to accomplish a response, the space between the speed table halves permitted emergency vehicles to cross the street centerline and slalom around them in a serpentine pathway (Figure 1). Constructed with the offset speed tables were median islands on the outside approaches to deter civilian drivers from crossing the centerline. In addition, a double yellow centerline was added approaching each island and quadruple yellow centerline with raised pavement markings were added between the speed table halves. The dense pavement markings between the speed table halves gave an illusion that a median continued the entire distance. The addition of the islands and striping was done to deter drivers from mimicking the pathway emergency vehicles could take.

Tests of the offset speed table with islands were conducted on two public streets, SE Market and SE 17th, in 1998. The testing of the offset speed hump with islands successfully demonstrated fire truck access speeds of 20-30 miles per hour through the pair of speed tables. Response delay was reduced from a maximum of 9.4 seconds for standard speed tables⁶ into the 2-second range.¹⁴ Video of the test site on SE Market showed no indication of confusion on the part of the drivers, nor any violations of drivers trying to avoid the device at any time.¹⁴ The testing also revealed that the offset speed table with median islands has limited application. Street width must be at least 40 feet, curb to curb, to provide for the serpentine path of Emergency Equipment and parking removal is often necessary opposite of each speed table half (see Figure 1). Additionally, where the street is less than 40 feet, transit drivers and other wide vehicle operators

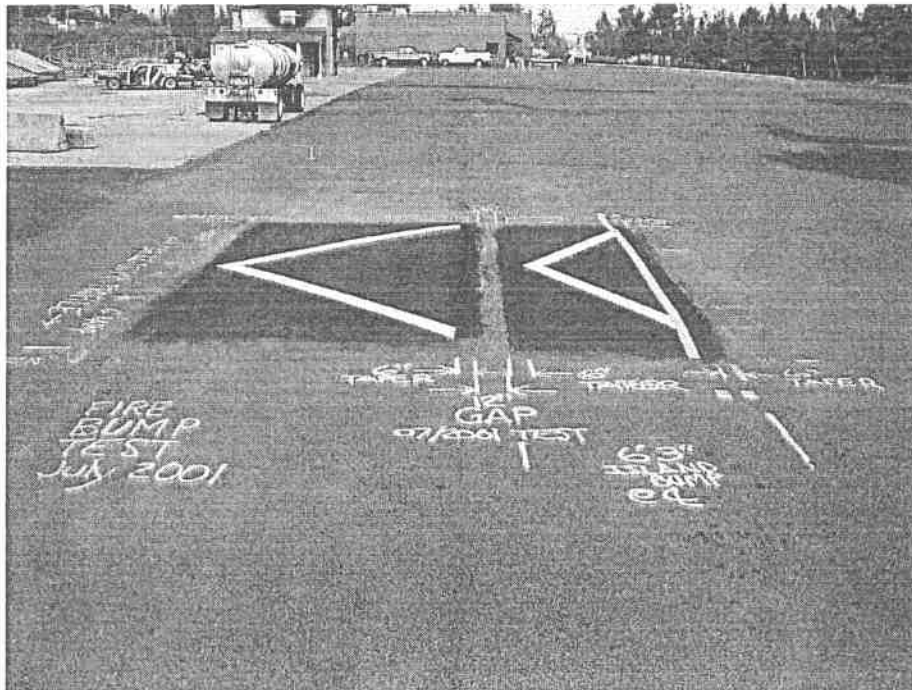
Photo 2. Offset Speed Hump with Channel Test Object – Looking Upstream.

PDOT constructed a prototype device at the Fire Bureau's training facility (Photo 2). This is a controlled area not subject to general traffic and permitted a variety of vehicles to test the device while data was collected. The primary purpose of this test was to determine what benefit the channeled speed table design provided for emergency vehicle response time. This testing also assisted in answering concerns of PDOT over driver control questions as well as refining the design and evaluating constructability issues.

The test device was constructed at Station 2 the week of July 16, 2001. The test object was a standard 22-foot speed table with 6-foot parabolic approach ramps and a 10-foot flat section with a maximum height of 3 inches. A channel was constructed offset from the centerline resulting in a 6-foot 3-inch wide cushion-like object that emergency equipment could straddle. The edge tapers for the channel and centerline edge were constructed with a 1:2 slope. Formal testing, using eight vehicles, was conducted on July 23, 2001. Each vehicle was driven over the device twice with drivers directed to aim for the channel. For the first run drivers were directed to attain 25 mph before crossing the speed table. For the second run the target speed was 30 mph. In past tests the typical speeds of fire trucks and engines crossing a standard 22-foot speed table varied from 14 mph to 21 mph.⁶ The majority of delay at the standard 22-foot speed table is due to the larger fire vehicle's slow acceleration. Attaining typical crossing speeds above 25 mph with the new design would represent a significant reduction in delay for emergency response and was the chosen target speed for a successful test. Each vehicle successfully traversed the test device near or above 25 mph as shown in Table 3.

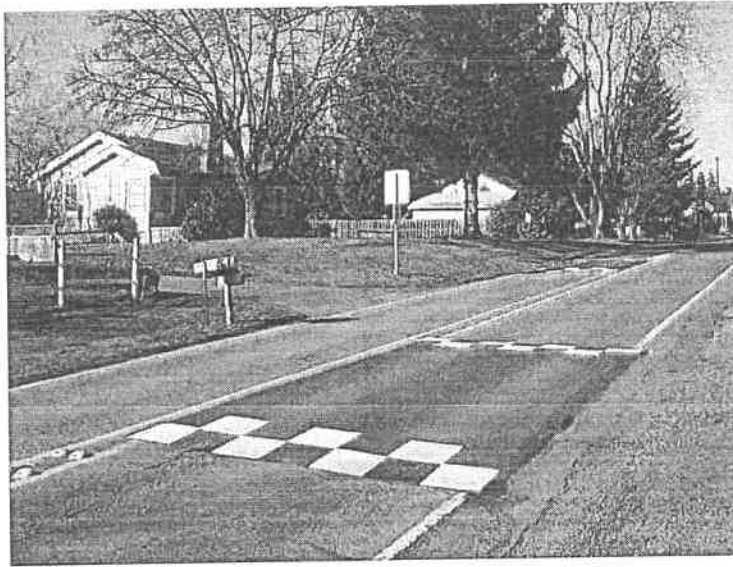
Photo 3. Beaverton Offset Speed Hump – SW 87th Avenue.

The nearby City of Beaverton installed offset speed tables without islands on SW 87th-Birchwood-Laurelwood in the summer of 2003 (Photo 3, next page). Offset speed tables were chosen due to the designation of the street for emergency response. Before construction of the speed tables the 85th percentile speed was measured at 34 mph in a 30-mph zone with 25% of

drivers exceeding the posted speed. After construction the 85th percentile speed reduced to 30 mph with 15% of drivers exceeding the posted speed. Vehicle volume on the street reduced from an average of 5800 vehicles per day (vpd) to 5400 vpd. The offset speed tables were originally constructed with only pavement striping to communicate to drivers to remain on their side of the street due to the weather. Subsequent to construction Beaverton received complaints from local residents about driver circumnavigation of the offset speed tables by crossing the centerline. The City of Beaverton added raised pavement markers with inset reflectors to deter such behavior (see Photo 4) after the weather warmed up in 2004. The City of Beaverton reports that complaints regarding centerline violations are no longer common from local residents.

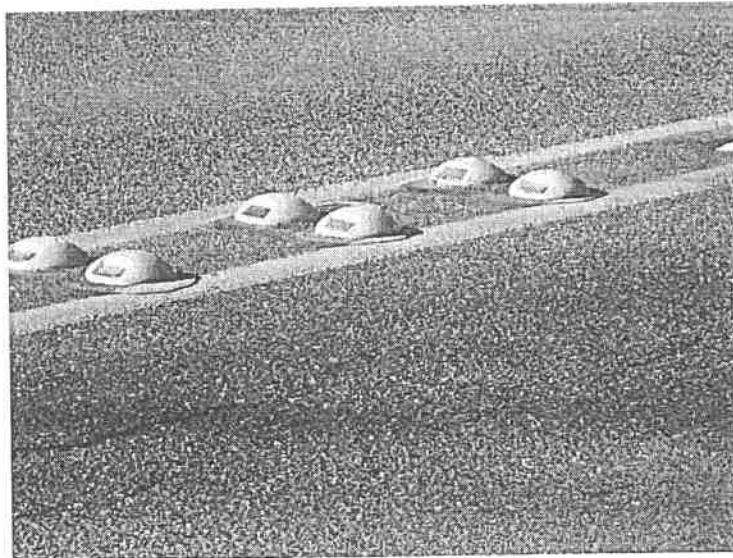
Photo 4. Beaverton Offset Speed Hump Centerline RRPMS.

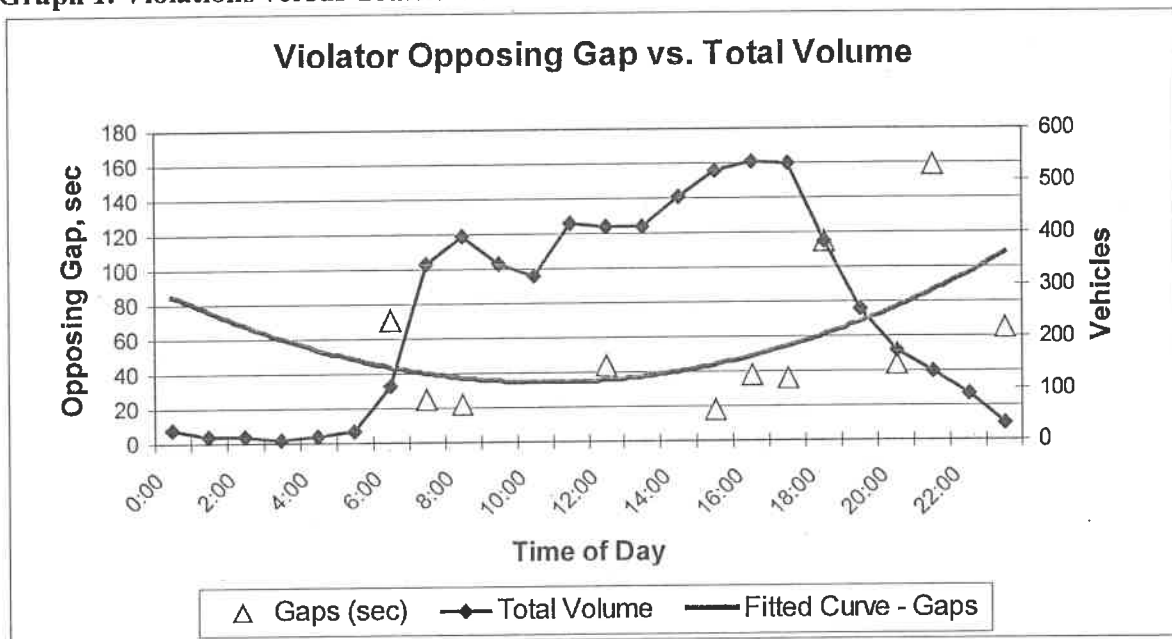
Graph 1. Violations versus Traffic Volume

It is expected that the offset speed table will be self-regulating in regards to centerline violations and such self-regulation is sensitive to opposing traffic volume. As opposing volumes increase fewer drivers likely to violate a double yellow centerline will do so (see graph 1). PDOT collected video at the Beaverton site to determine the frequency of centerline violations. Approximately 13 vehicles in a 24-hour period violated the centerline to some extent, either completely or partially avoiding the offset speed tables. This represents a violation of 0.22% of the total population of drivers. The average length of time a driver was within a portion of the opposing lane (exposure) during such maneuvers was 2.88 seconds with a standard deviation of 1.13 seconds. The opposing headway gap, the length of time before the next opposing vehicle passed the offset speed table after a violation occurred, averaged 22 seconds with a standard deviation of 10.43 seconds. The exposure and opposing headway analyses are conservative in that data corresponding to opposing gaps in excess of 60 seconds (5 of the 13) were discarded.
