Calculation Book Report

Calculation Book No. 441 **Standard Drawing No.** P-441

Drawing Title: 22' Asphalt Local Speed Bump

Split Speed Bump

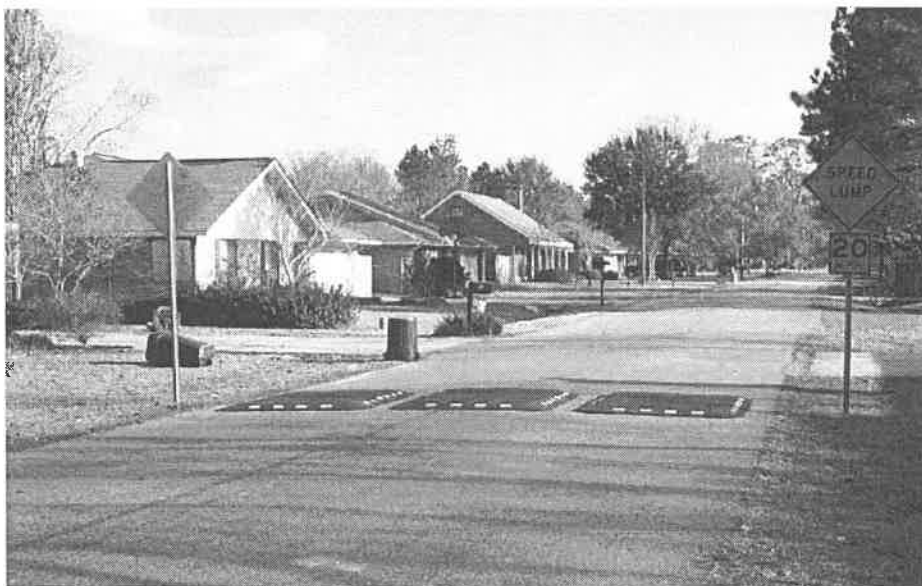
Photo 1. Speed Cushion, Lafayette, LA.

Compounding the issue of track width was the common use of dual rear wheels for heavier vehicles like transit buses and fire trucks. Dual rear wheels in heavy vehicles mean the clear space between the wheels of large vehicles more closely matches the track width of sedans and sport-utility vehicles common in the U.S. Finding a speed cushion wide enough to slow most private vehicles and yet narrow enough to permit fire trucks and transit vehicles to pass easily, without overloading those heavier vehicles' rear axles proved difficult. Also, the use of speed cushions means there are intentional gaps, or channels, between devices in a multi-device installation (see Photo 1).

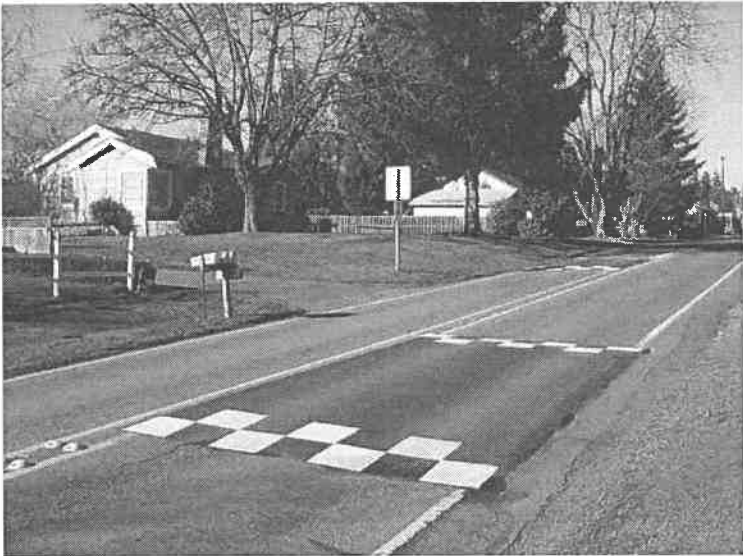
Photo 3. Beaverton Offset Speed Hump – SW 87th Avenue.

The nearby City of Beaverton installed offset speed tables without islands on SW 87th-Birchwood-Laurelwood in the summer of 2003 (Photo 3, next page). Offset speed tables were chosen due to the designation of the street for emergency response. Before construction of the speed tables the 85th percentile speed was measured at 34 mph in a 30-mph zone with 25% of

drivers exceeding the posted speed. After construction the 85th percentile speed reduced to 30 mph with 15% of drivers exceeding the posted speed. Vehicle volume on the street reduced from an average of 5800 vehicles per day (vpd) to 5400 vpd. The offset speed tables were originally constructed with only pavement striping to communicate to drivers to remain on their side of the street due to the weather. Subsequent to construction Beaverton received complaints from local residents about driver circumnavigation of the offset speed tables by crossing the centerline. The City of Beaverton added raised pavement markers with inset reflectors to deter such behavior (see Photo 4) after the weather warmed up in 2004. The City of Beaverton reports that complaints regarding centerline violations are no longer common from local residents.

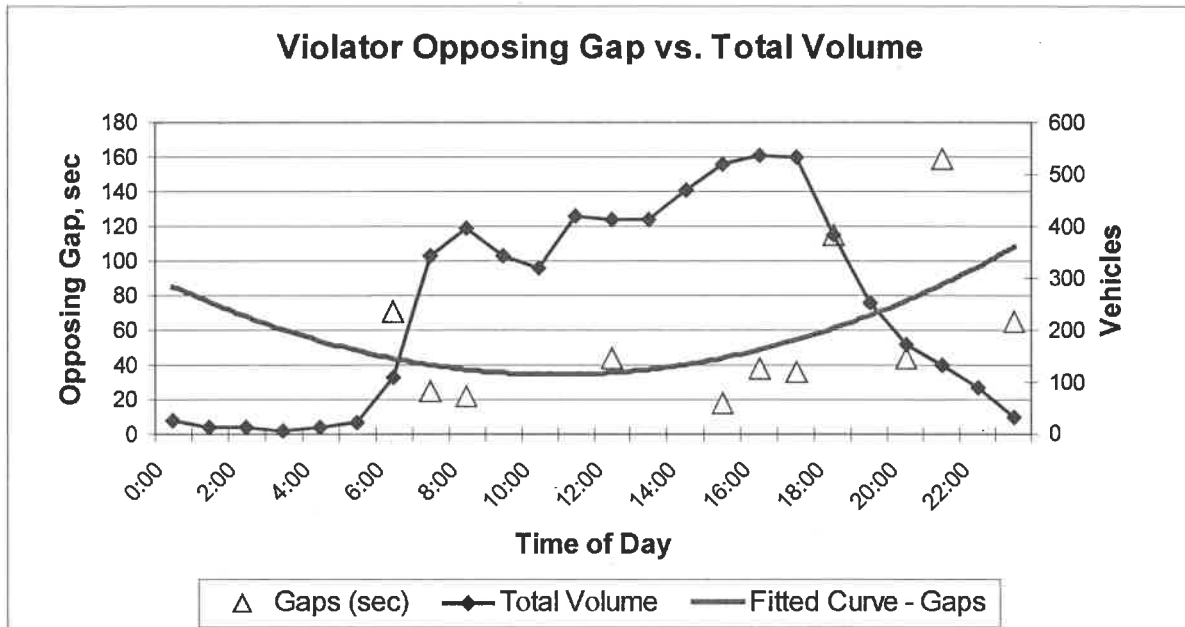
Graph 1. Violations versus Traffic Volume

It is expected that the offset speed table will be self-regulating in regards to centerline violations and such self-regulation is sensitive to opposing traffic volume. As opposing volumes increase fewer drivers likely to violate a double yellow centerline will do so (see graph 1). PDOT collected video at the Beaverton site to determine the frequency of centerline violations. Approximately 13 vehicles in a 24-hour period violated the centerline to some extent, either completely or partially avoiding the offset speed tables. This represents a violation of 0.22% of the total population of drivers. The average length of time a driver was within a portion of the opposing lane (exposure) during such maneuvers was 2.88 seconds with a standard deviation of 1.13 seconds. The opposing headway gap, the length of time before the next opposing vehicle passed the offset speed table after a violation occurred, averaged 22 seconds with a standard deviation of 10.43 seconds. The exposure and opposing headway analyses are conservative in that data corresponding to opposing gaps in excess of 60 seconds (5 of the 13) were discarded.
